ŠTO JE VELIKI TABOR?

ISTRAŽIVANJA I KONZERVATORSKO-RESTAURATORSKI RADOVI TIJEKOM 20. STOLJEĆA

KONZERVATORSKO-RESTAURATORSKA ISTRAŽIVANJA PALASA VELIKOG TABORA

PRIJEDLOG PREZENTACIJE I PROJEKT OBNOVE
 PROPOSAL FOR THE PRESENTATION AND
 RECONSTRUCTION PROJECT

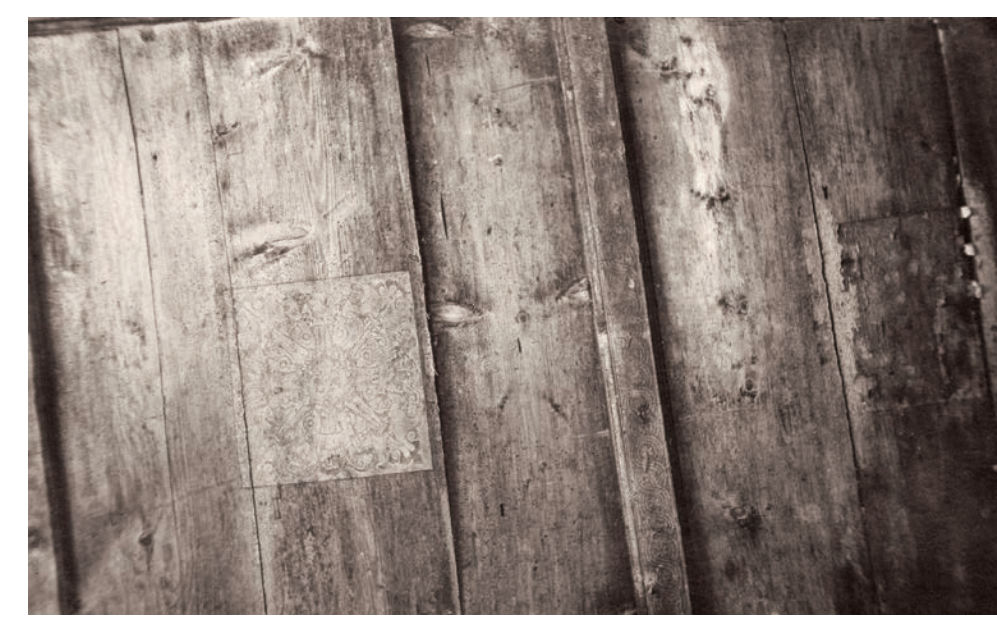
Detalj drvenog stropa na 1. katu palasa, 1911.
Detail of the wooden ceiling on the 1st floor of the palace, 1911

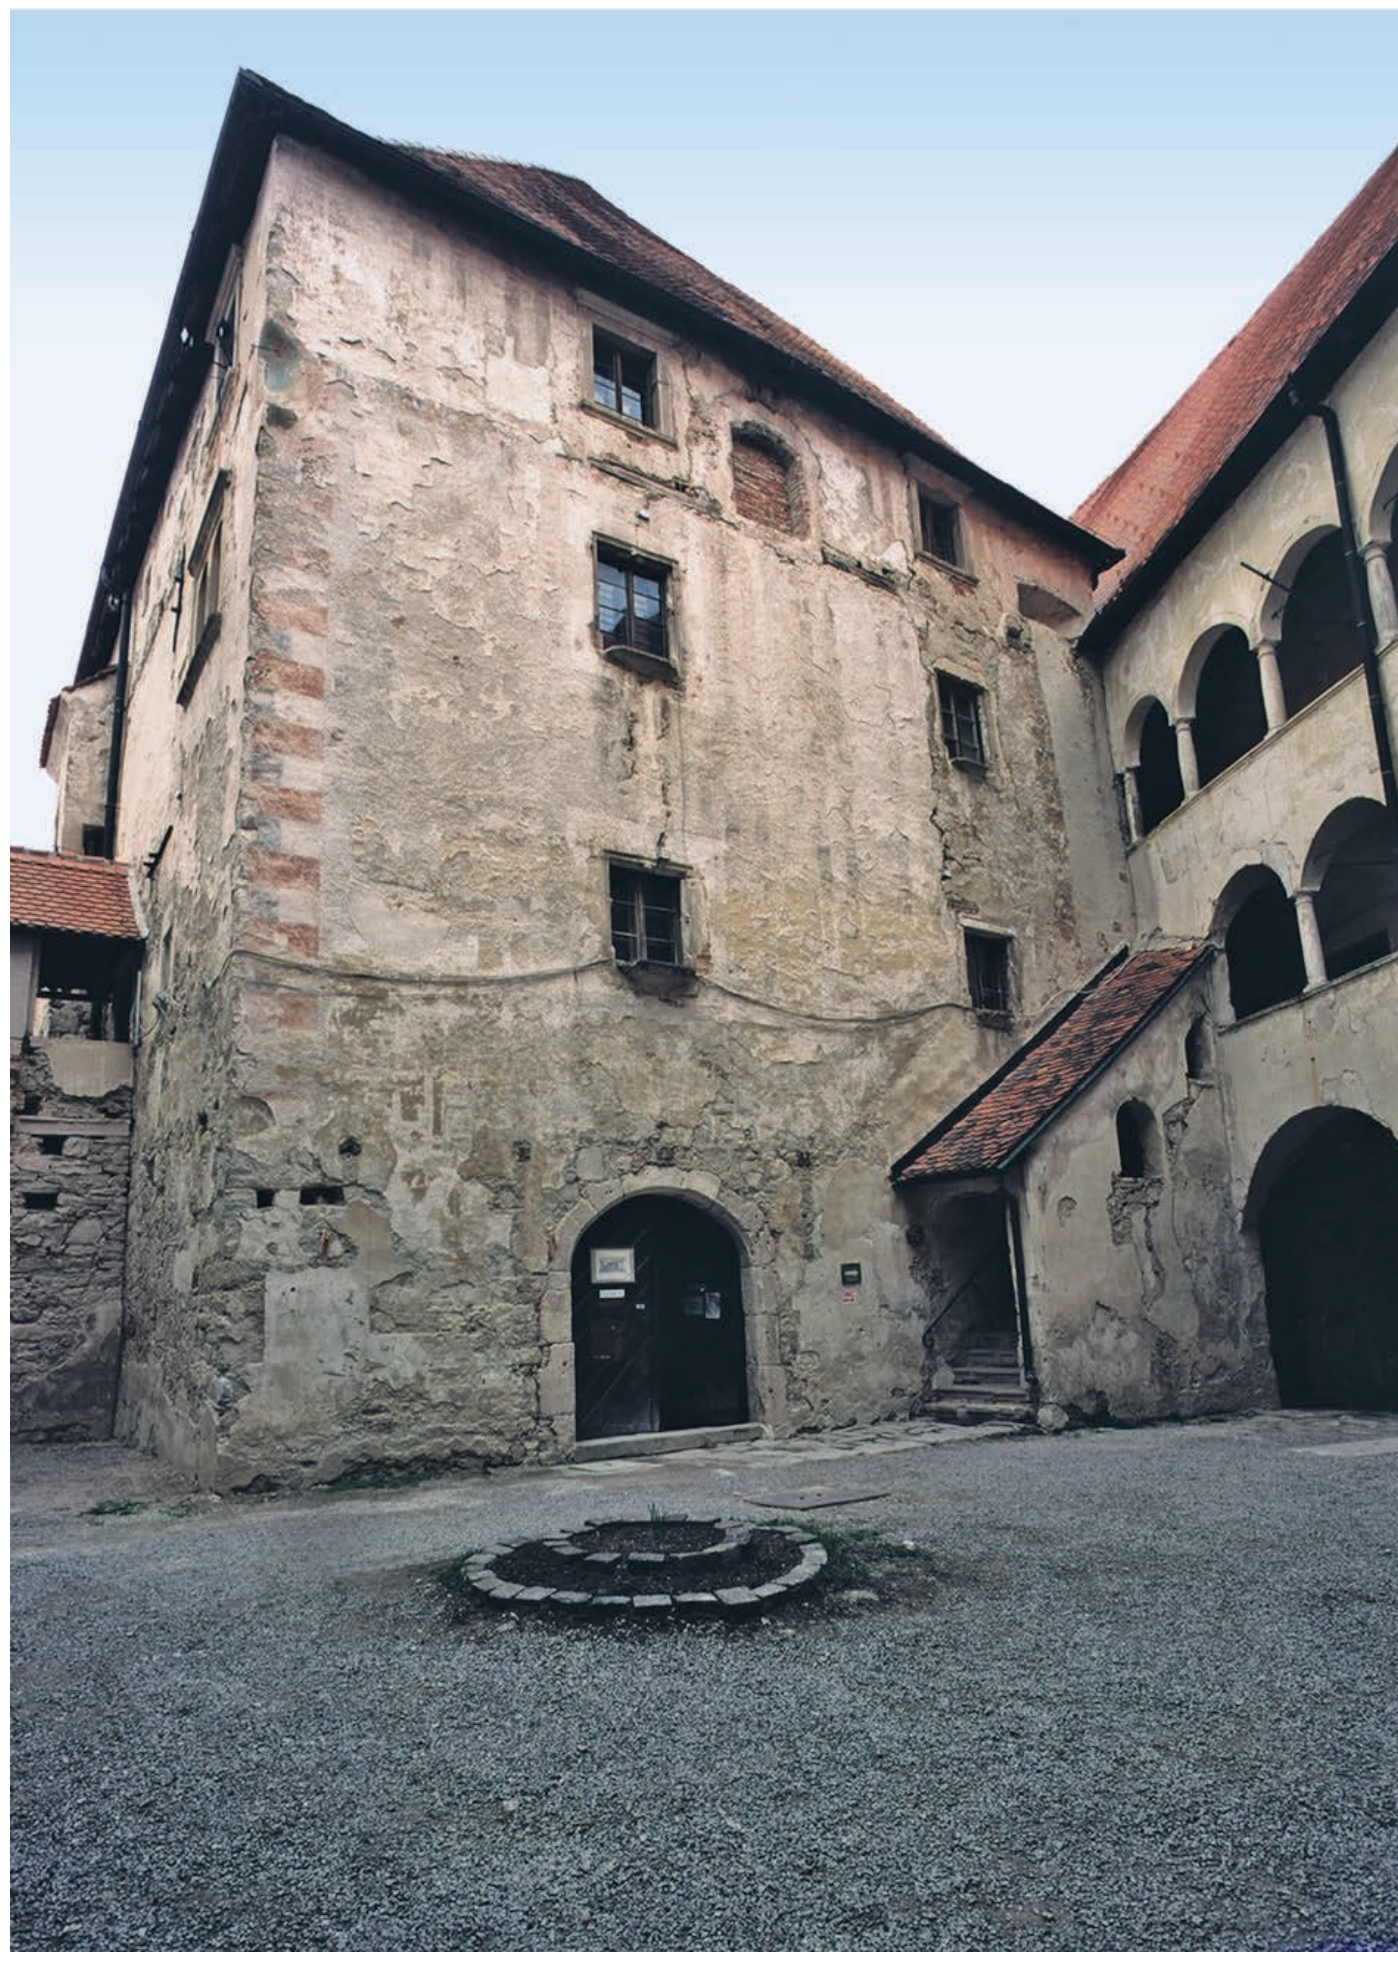
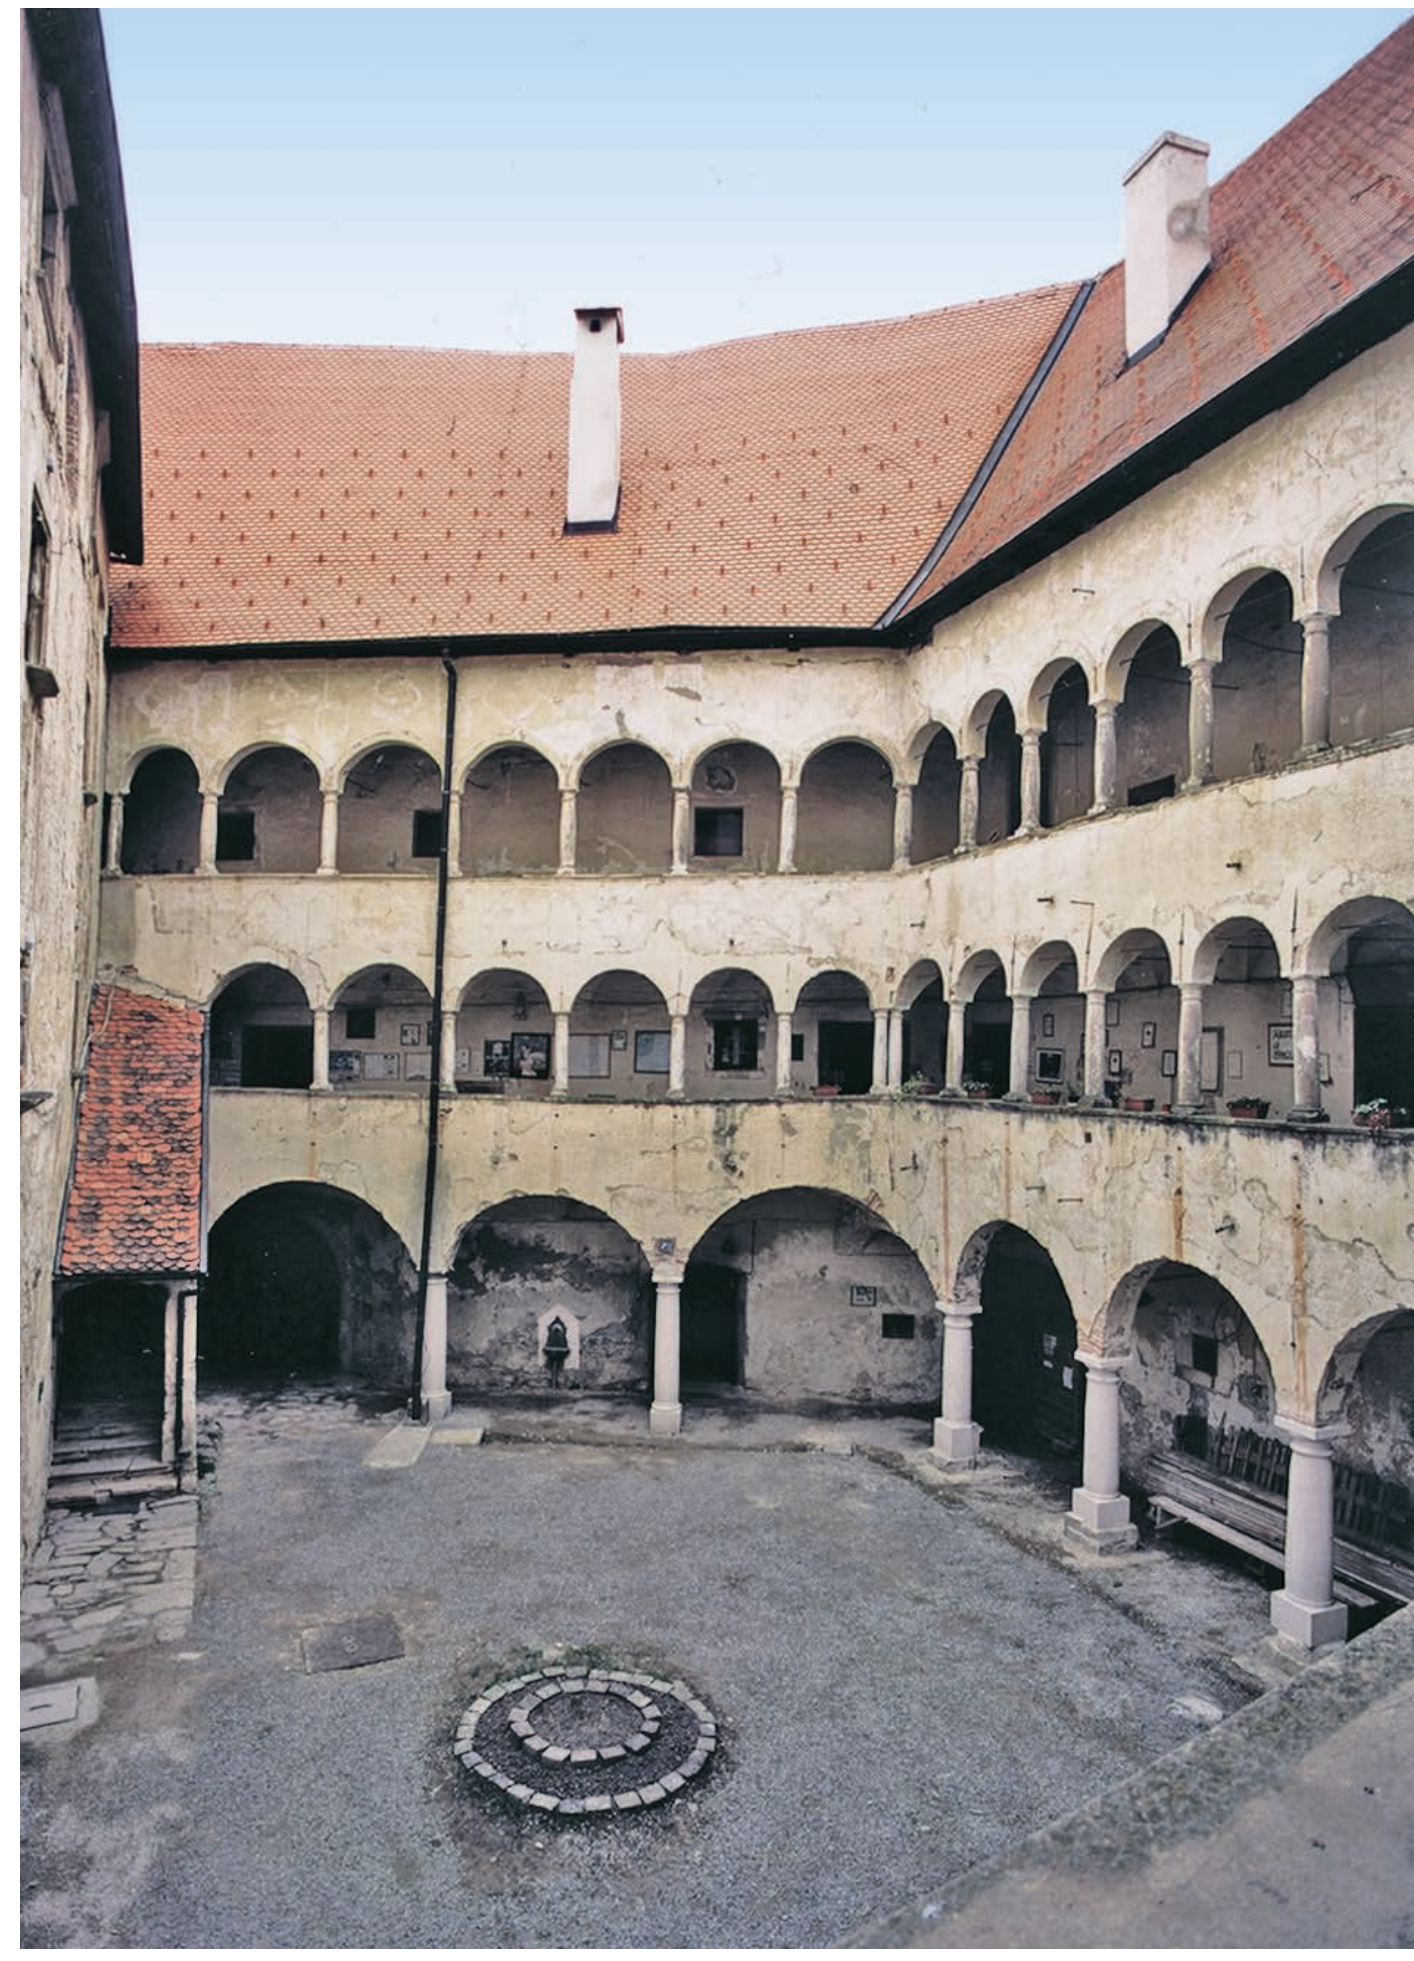
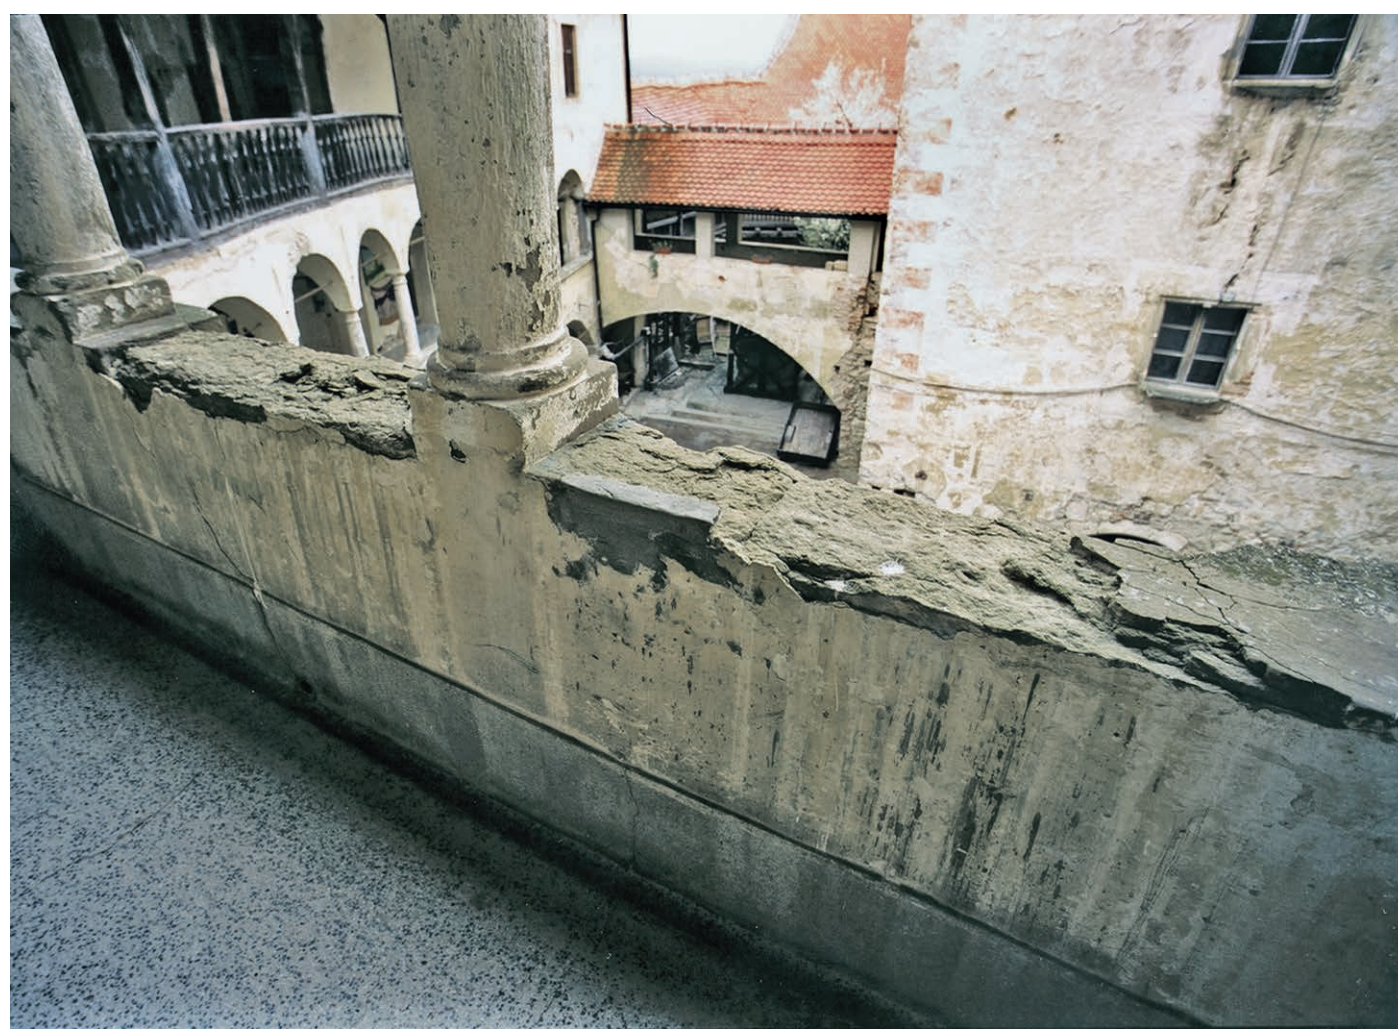
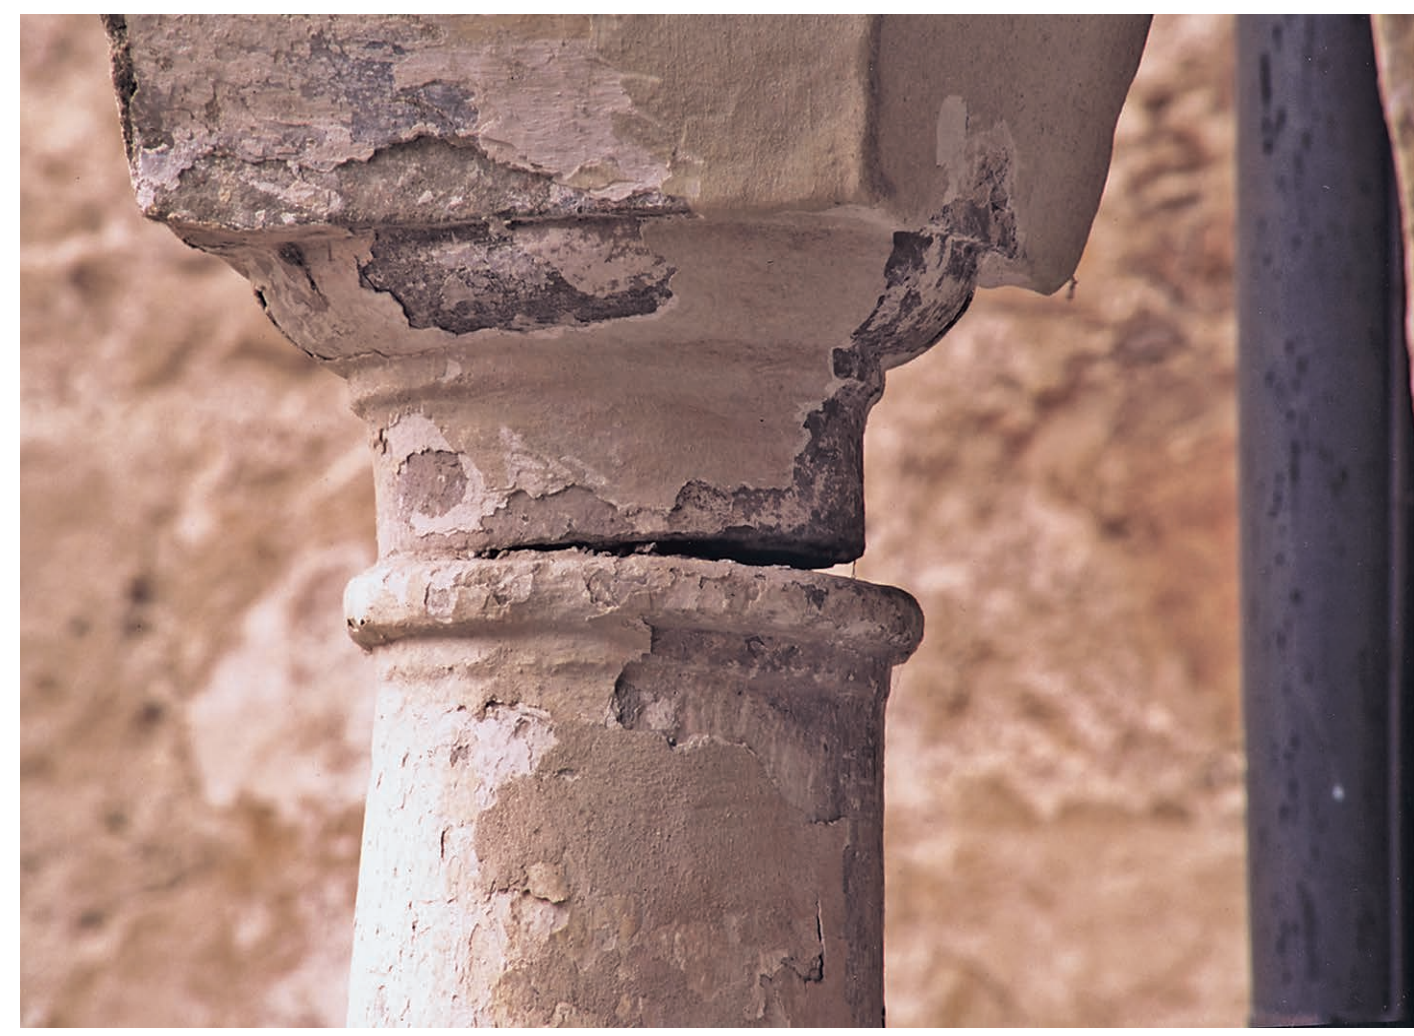
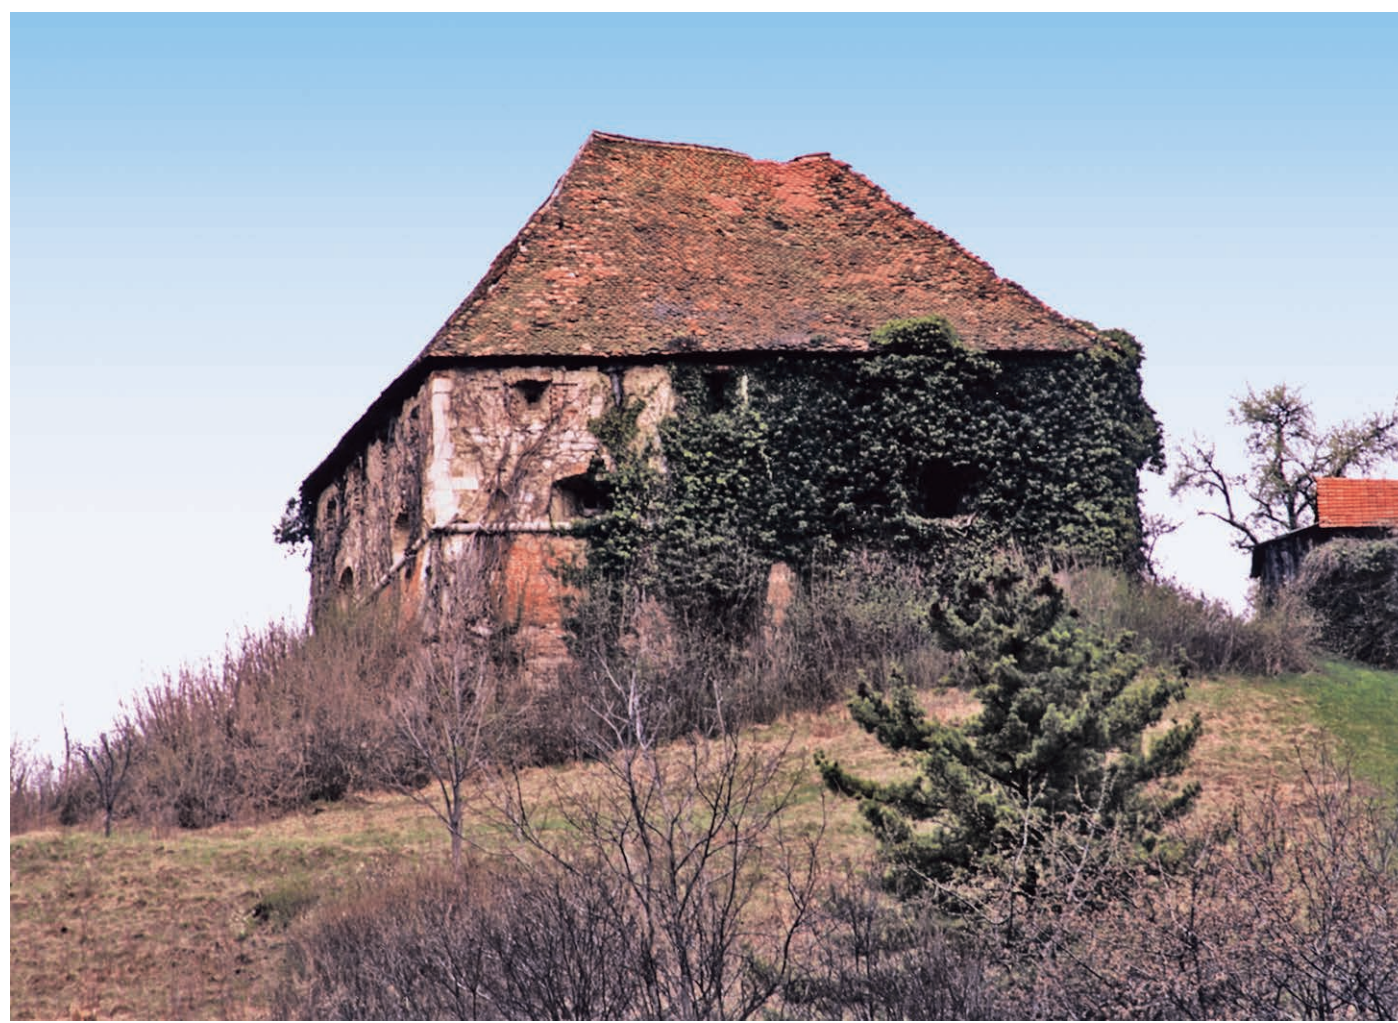
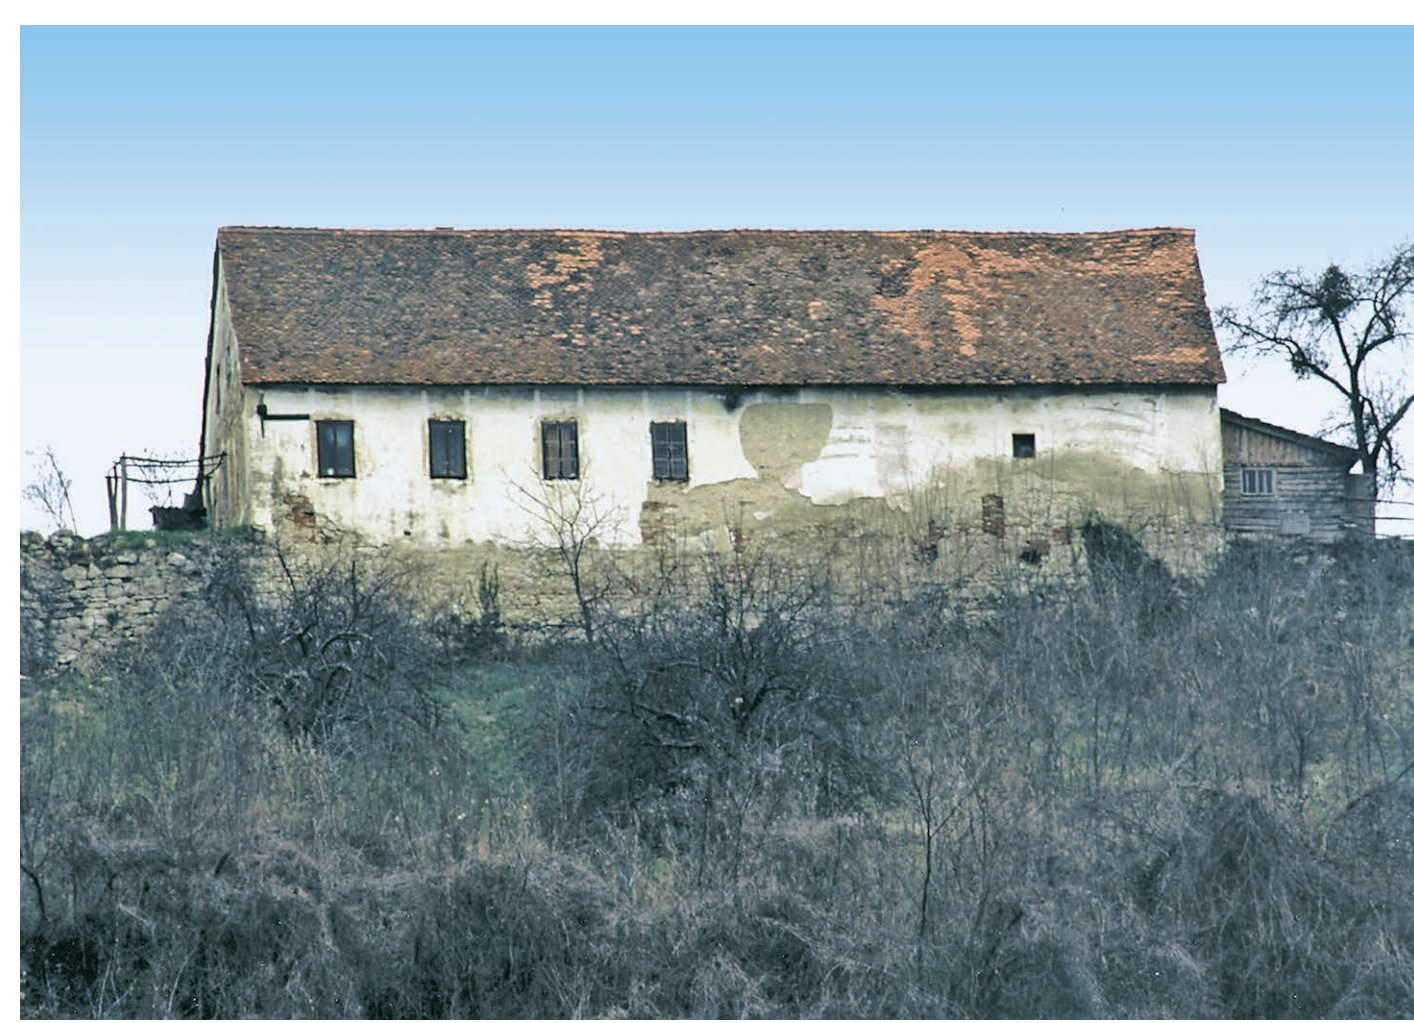
Veliki Tabor prije radova obnove
Veliki Tabor before the reconstruction works

Tabor's condition before the reconstruction works was extremely bad, ranging from dilapidated artistic values of this architectonic complex to the bad condition of constructions, bad statics and materials.

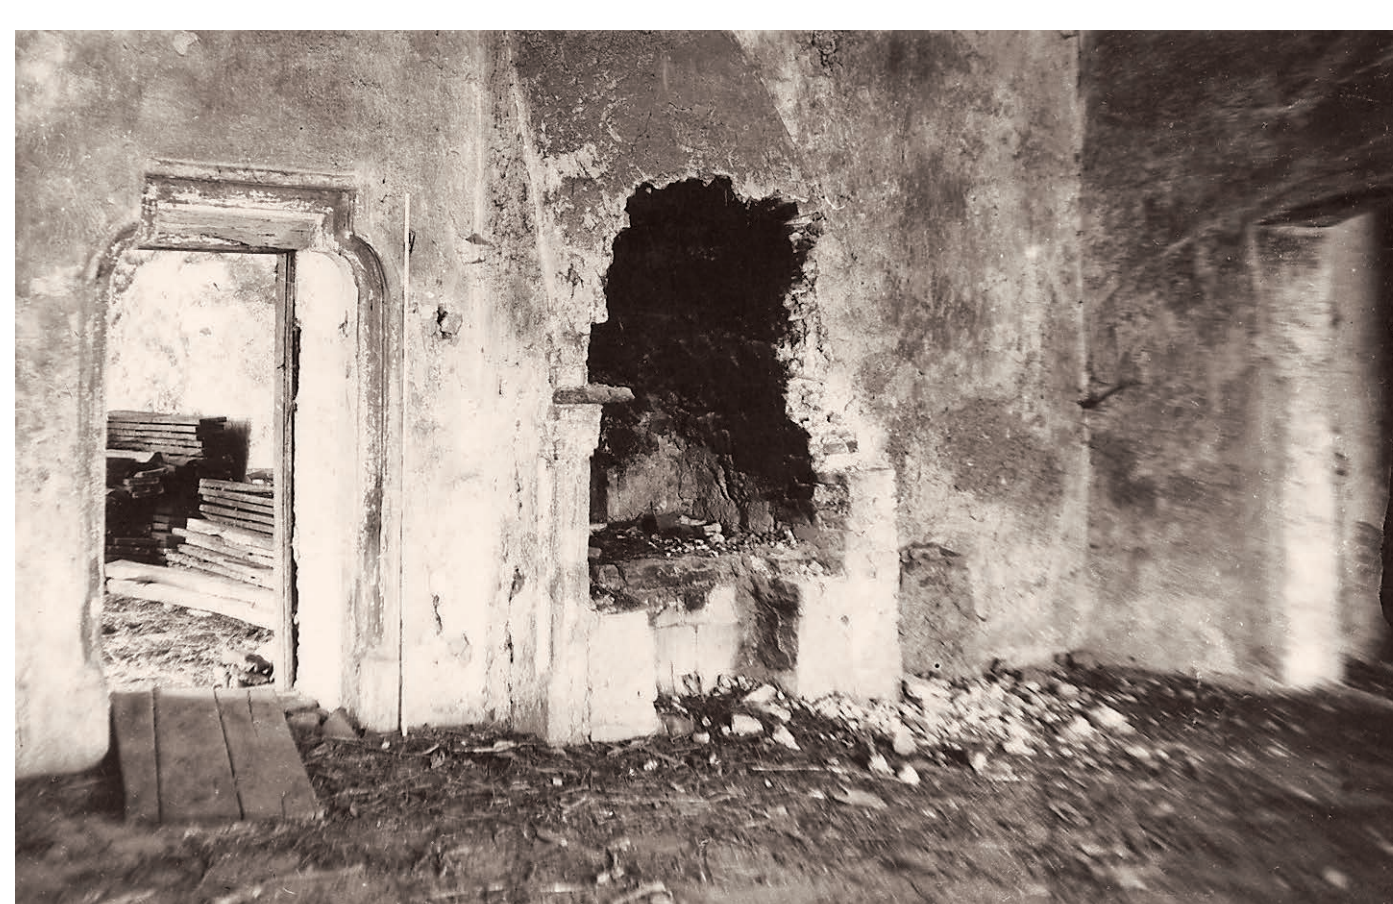
Ulazna prostorija 1. kata palasa, 1911. / Entrance room on the 1st floor of the palace, 1911

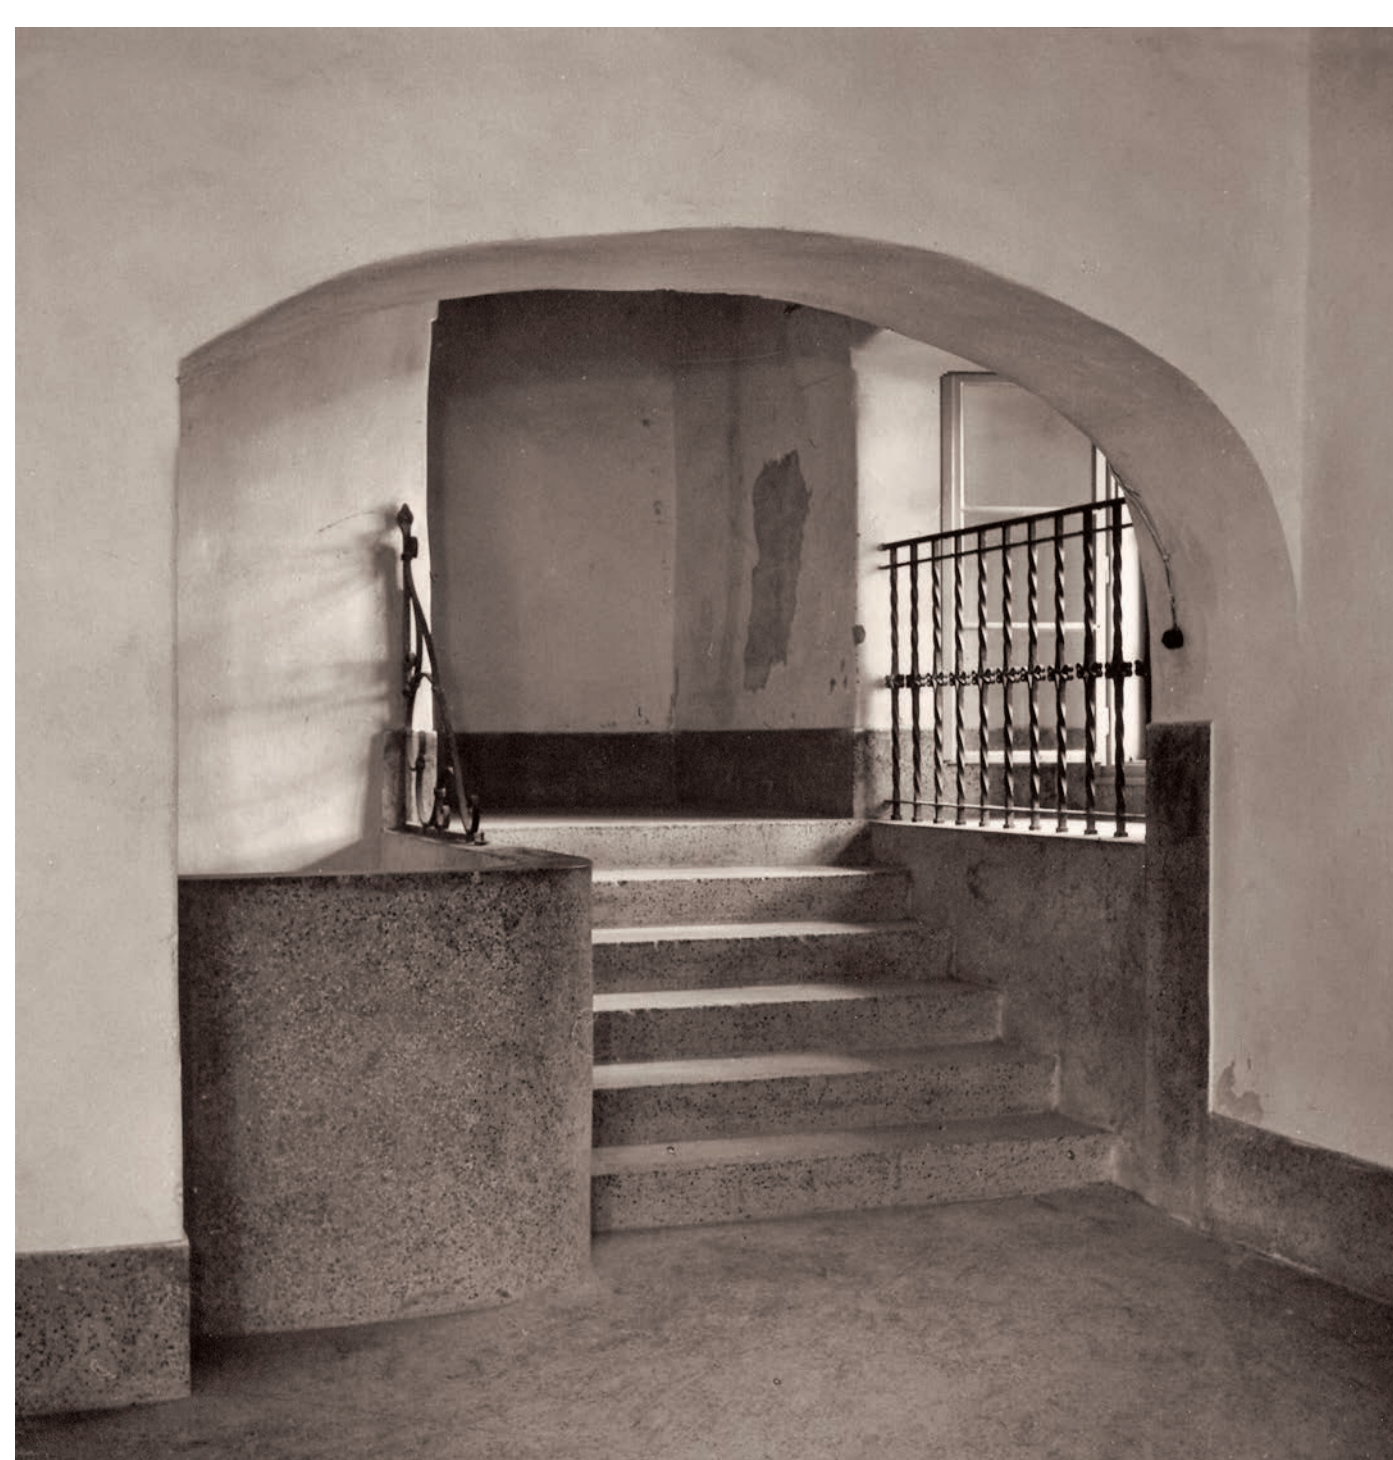
The interior of the palace was radically changed, and the works included building up concrete stairways, new partition walls and installation of sanitary facilities. Water, canalisation and electrical installations were installed. Floors and ceiling were replaced, as well as the woodwork of the doors and windows.

Betonsko stubište, 1954. / Concrete stairway, 1954

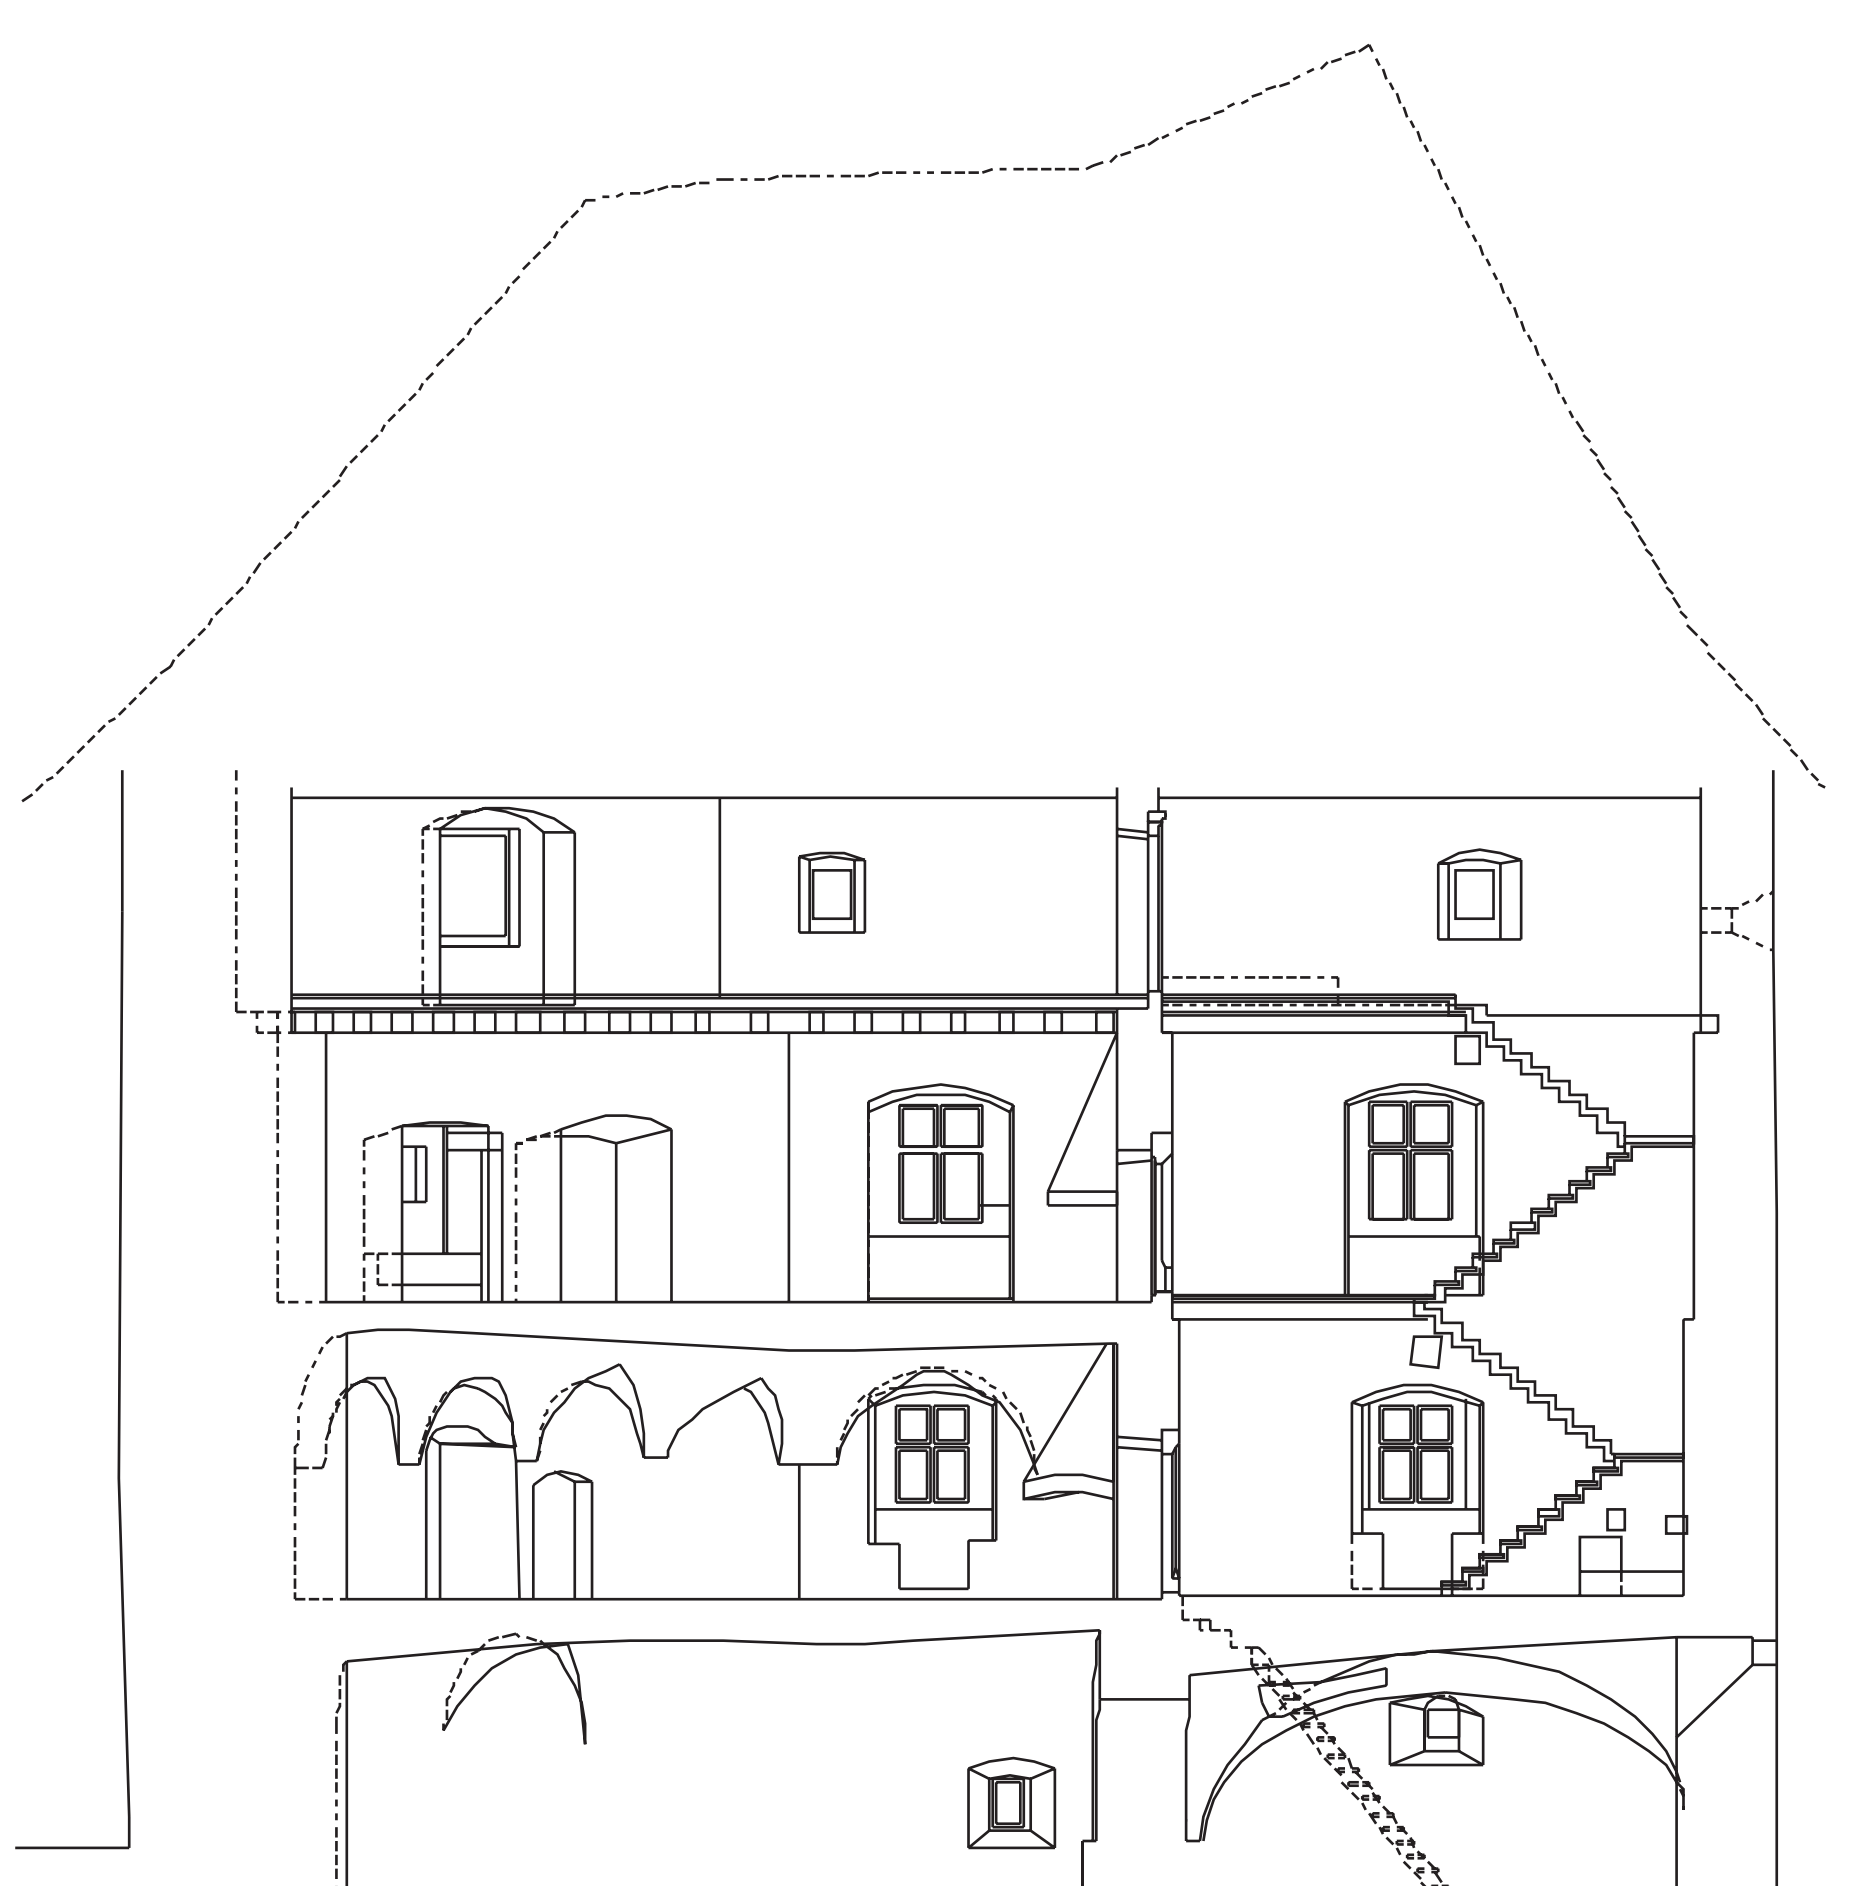
Presjek 1-1 / Cross-section 1-1

Glavni ulaz u palas nalazi se na prvom katu južnog pročelja, a pristupa mu se preko dvorišnih galerija i zidanog mosta. Istraživanjima je utvrđeno da su prostori prvog i drugog kata u kasnogotičkoj fazi imali jednak tlocrtni raspored. Bili su podijeljeni na tri prostorije nepravilnog tlocrta. Budući da se prezentira stambeni ambijent 16. stoljeća, uklonjena je zidana lučne konstrukcije ispred stubišta na prvom katu te pregradni zid iznad luka na drugom katu. Ujedno se uklonilo i postojeće armiranobetonsko stubište na čijem je mjestu novo suvremeno rješenje.

U skladu s rezultatima istraživanja prezentirani su pojedini arhitektonski elementi: kamini u ulaznom dijelu i u kuhinji te peć u južnoj prostoriji prvog kata, i jednako tako, na drugom katu kamini u istočnoj i južnoj prostoriji, zatim kameni češki prozori i okviri s profiliranim križevima, rekonstrukcija stolarije i povijesnog ostakljenja prozora bucnama te kameni gotički okviri vrata. Novi rekonstruirani elementi su i stupovi u ulaznoj prostoriji prvoga kata i prostoriji drugoga kata iznad nje.

Na trećem katu zadržan je zatečeni tlocrtni raspored dobiven nakon prenamjene i pregradnje žitnice u stambeni prostor tijekom 17. i 18. stoljeća. Prezentirana su zatečena izvorna barokna vrata, a dvojica su rekonstruirana prema njima. Presentacijom je obuhvaćen i žitni otvor u istočnom zidu.

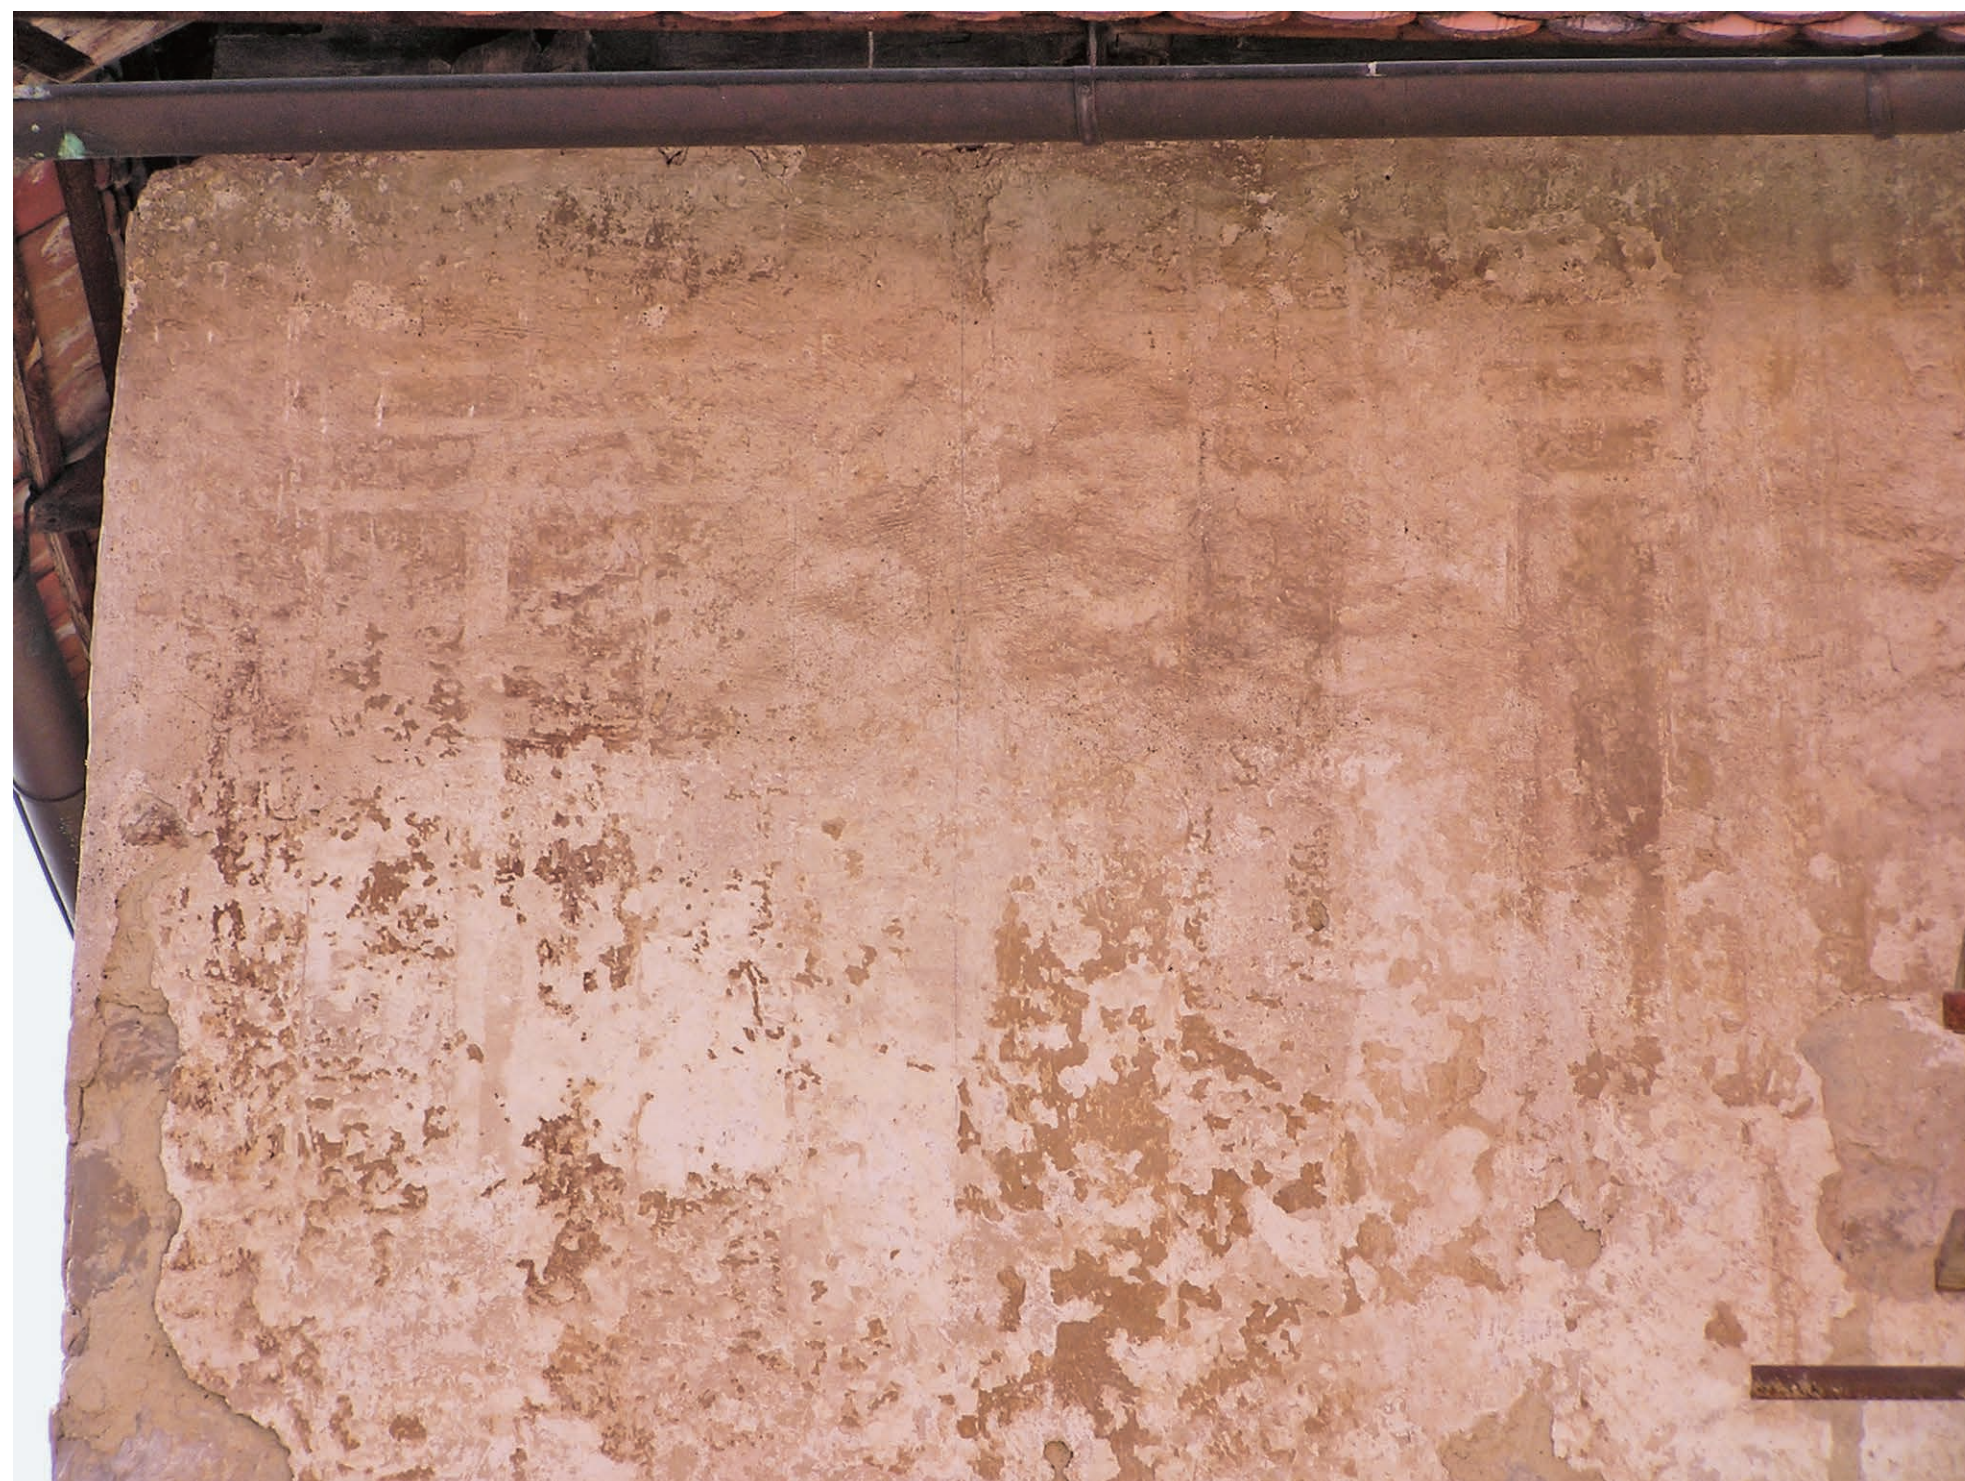
Ostaci baroknog oslika
Remains of the baroque wall painting

Na istočnom i južnom pročelju retuširan je kasnogotički oslik u zoni prizemlja te prvog i drugog kata. Na mjestima gdje je oslik oštećen ili nije sačuvan izvedena je rekonstrukcija. Žbukani sloj s baroknim oslikom u zoni ispod krovne nadstrešnice na trećem katu je učvršćen, a prezentiran je sloj žbuke iz 1537. s ispisanom godinom.

On the eastern and southern façades, the late-gothic wall painting was retouched in the areas of the ground, first and second floors. The spots where the wall painting was damaged or not properly preserved were reconstructed. The plaster layer with the baroque wall painting in the area under the roof cover on the third floor was strengthened, and the plaster layer from 1537, clearly stating the year, was presented.
