ŠTO JE VELIKI TABOR?

ISTRAŽIVANJA I KONZERVATORSKO-RESTAURATORSKI RADOVI TIJEKOM 20. STOLJEĆA

KONZERVATORSKO-RESTAURATORSKA ISTRAŽIVANJA PALASA VELIKOG TABORA

PRIJEDLOG PREZENTACIJE I PROJEKT OBNOVE
 PROPOSAL FOR THE PRESENTATION AND
 RECONSTRUCTION PROJECT

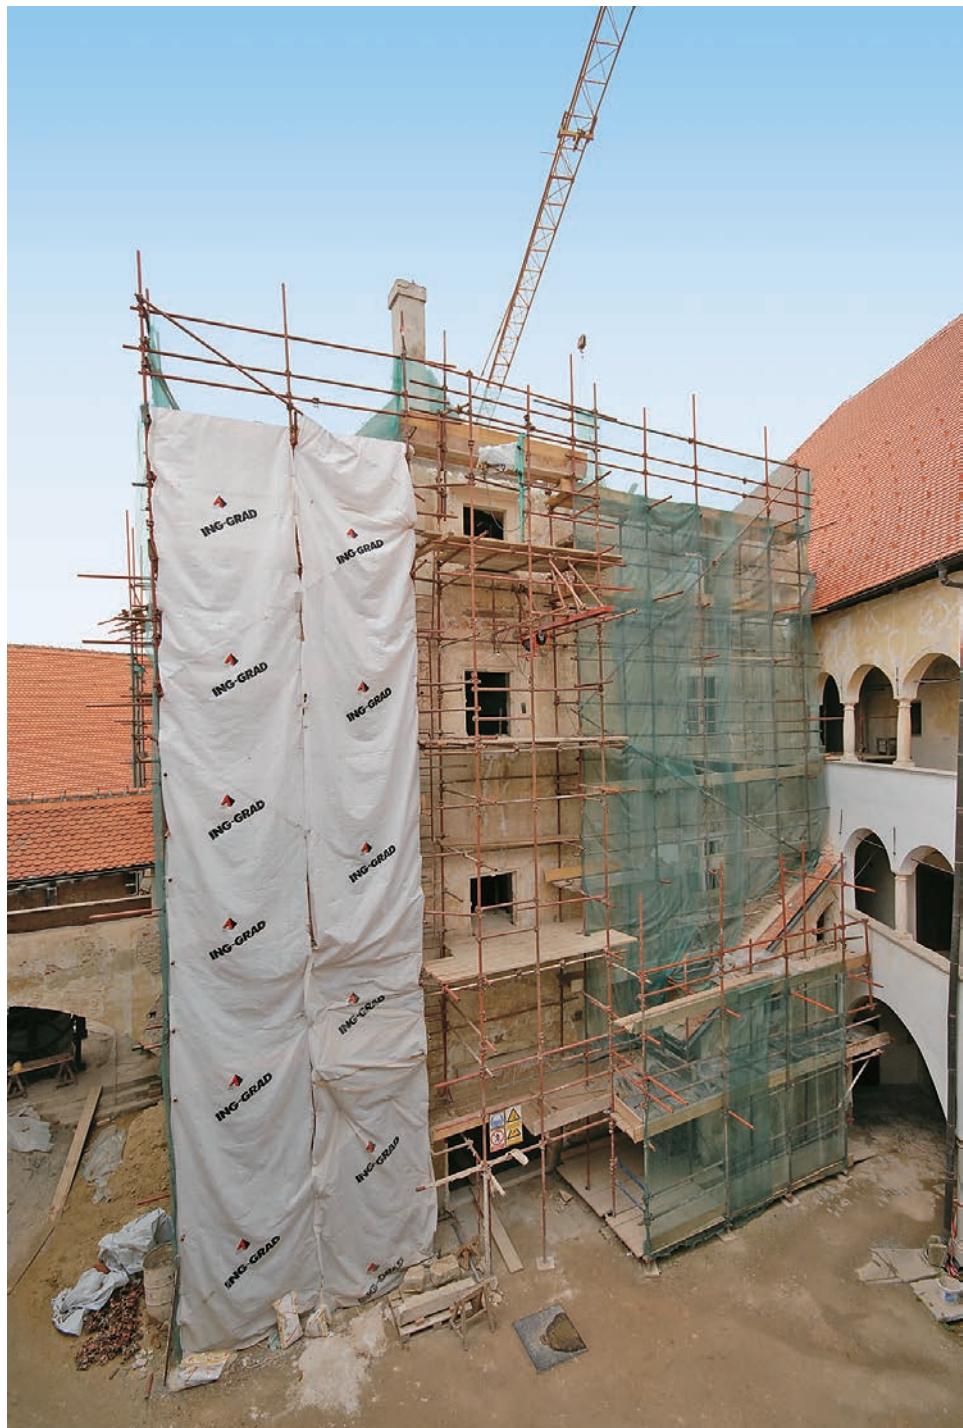
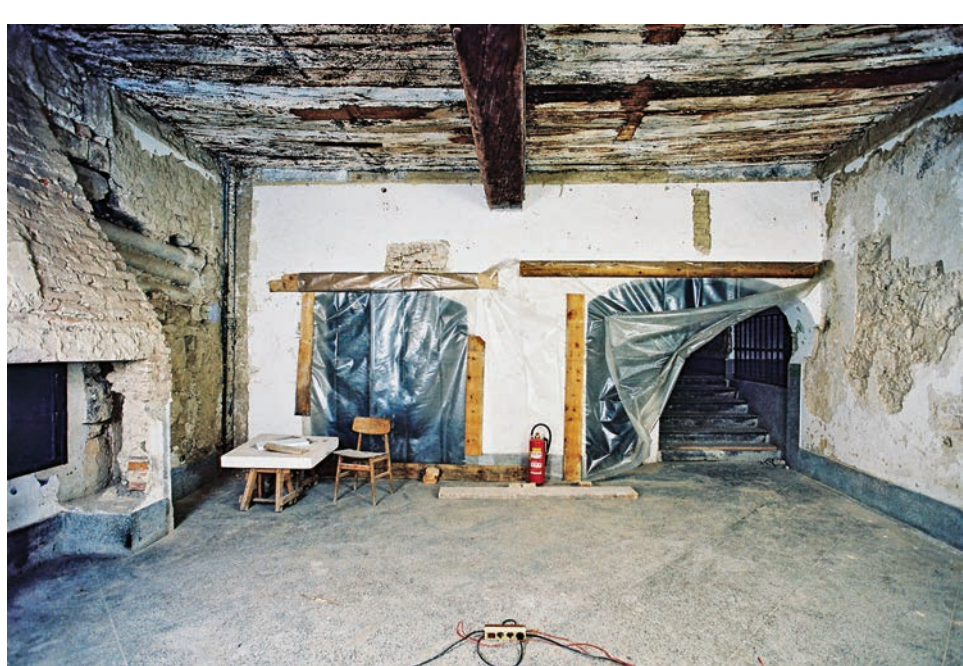
Detaljnim pregledom zatečene krovne konstrukcije, utvrđeno je da je dotrajala, a od vremena gradnje je u nekoliko navrata prerađivana i često nestručno popravljana što je rezultiralo njenom deformacijom. Zbog deformacije krovišta i nepovoljnog djelovanja sila na zidnom plaštu došlo je do djelomične razgradnje uglova. Dotrajala građa je zamijenjena, a krovište je rekonstruirano prema stanju iz polovice 16. stoljeća. Trošan i oštećen crijep u većoj je mjeri zamijenjen novim. Novi biber crijep po obliku je identičan najstarijem povijesnom predlošku s krova palasa. Od starog crijepa, koji je bio u dobrom stanju, pokrivena je istočna strana krovišta orijentirana na unutarnje dvorište. Zbog lošeg građevinskog stanja svi su vanjski zidovi statički konsolidirani. Sanacija je izvedena s unutarnje strane zidova.

A detailed check of the found roof construction determined that it had deteriorated, and from the time of its construction, it had been reconstructed several times, often non-professionally, which resulted in its deformation. Because of the roof deformation and unfavourable influence of the forces on the wall upper layers, the angles were partially disintegrated. Deteriorated materials were changed, and the roof was reconstructed according to its state in the mid 16th century. Dilapidated and damaged tiles were mainly replaced by new ones. New large-profile tiles have an identical form as the oldest historical template from the palace roof. The eastern side of the roof oriented towards the inner courtyard has been covered by old tiles that were still in a good state. Because of the bad construction condition, all external walls were statically consolidated. Repairs have been made on the internal side of the walls.

Nakon provedene analize stanja međukatnih konstrukcija, izvedena je sanacija istih svodova od opeke i kamena te drvene građe.

After the analysis of the constructions between floors, the constructions made of brick and stone arches as well as woodworks have been repaired.
