THE PERISTYLE
CONSERVATION-
RESTORATION
WORKS

On the occasion of the exhibition about the second phase of the conservation-restoration treatment of the Peristyle

Conservation-Restoration works on the façade of the Skočibučić-Lukaris Palace

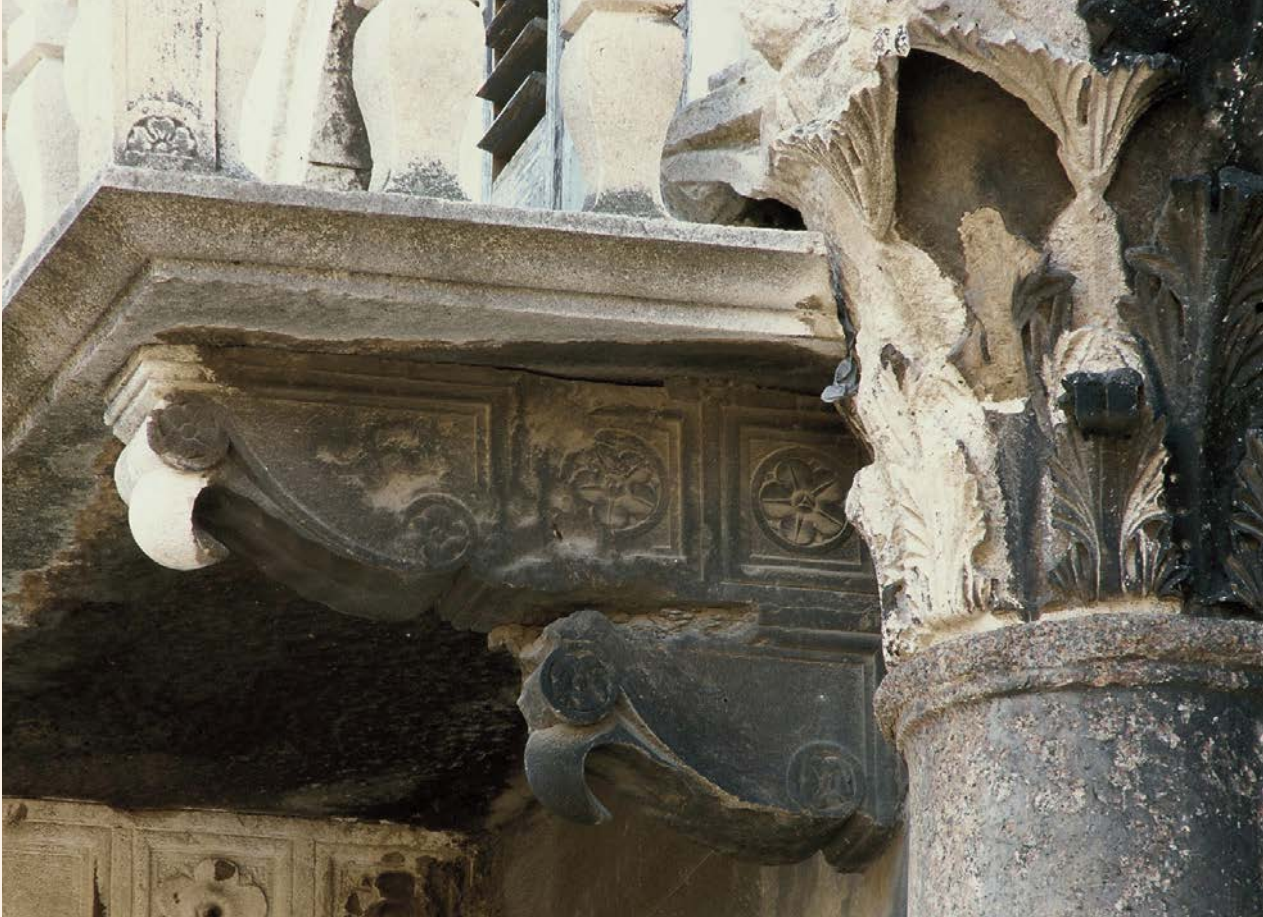
Photograph: Detail of the façade of the Skočibučić-Lukaris Palace, the condition before the conservation-restoration operation

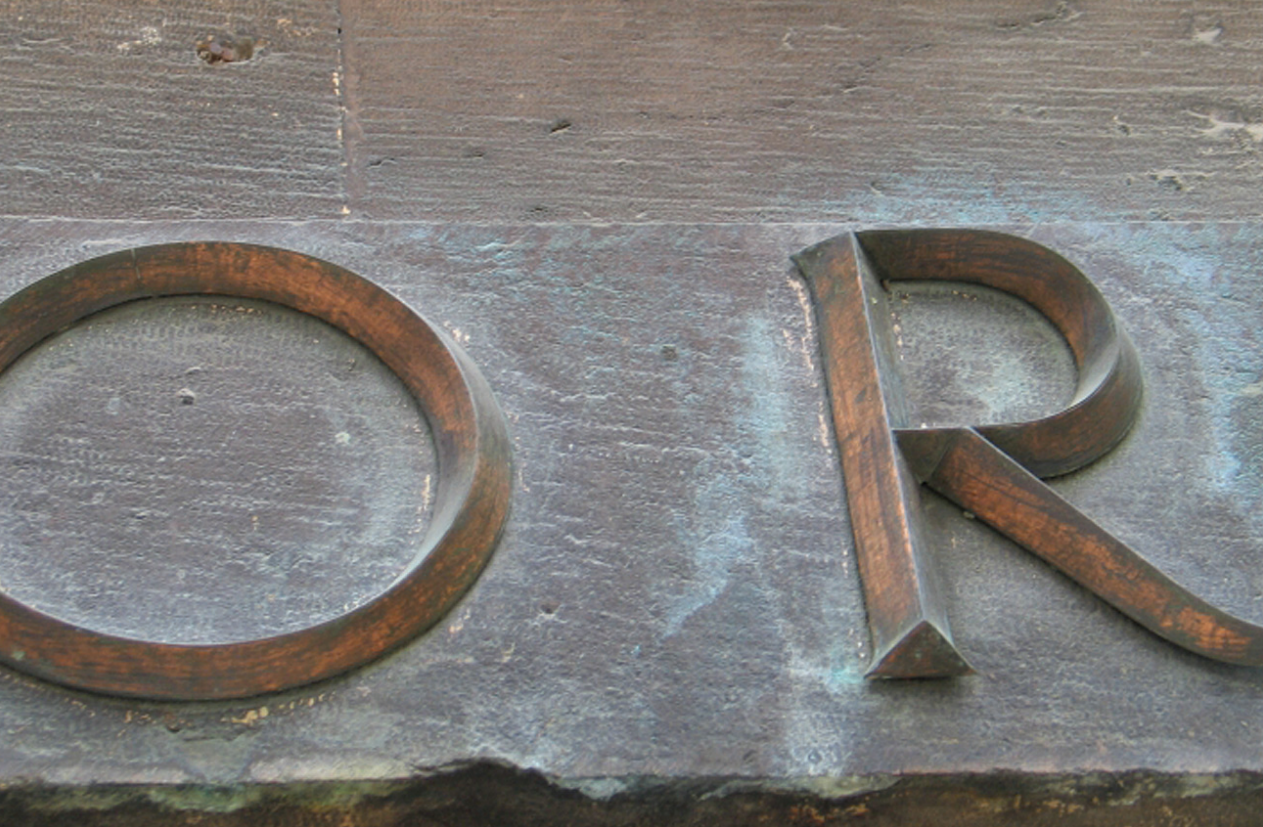
Top photograph: Detail of the architrave of the portal in the ground floor of the Grisogono-Cipci Palace, condition before the operation

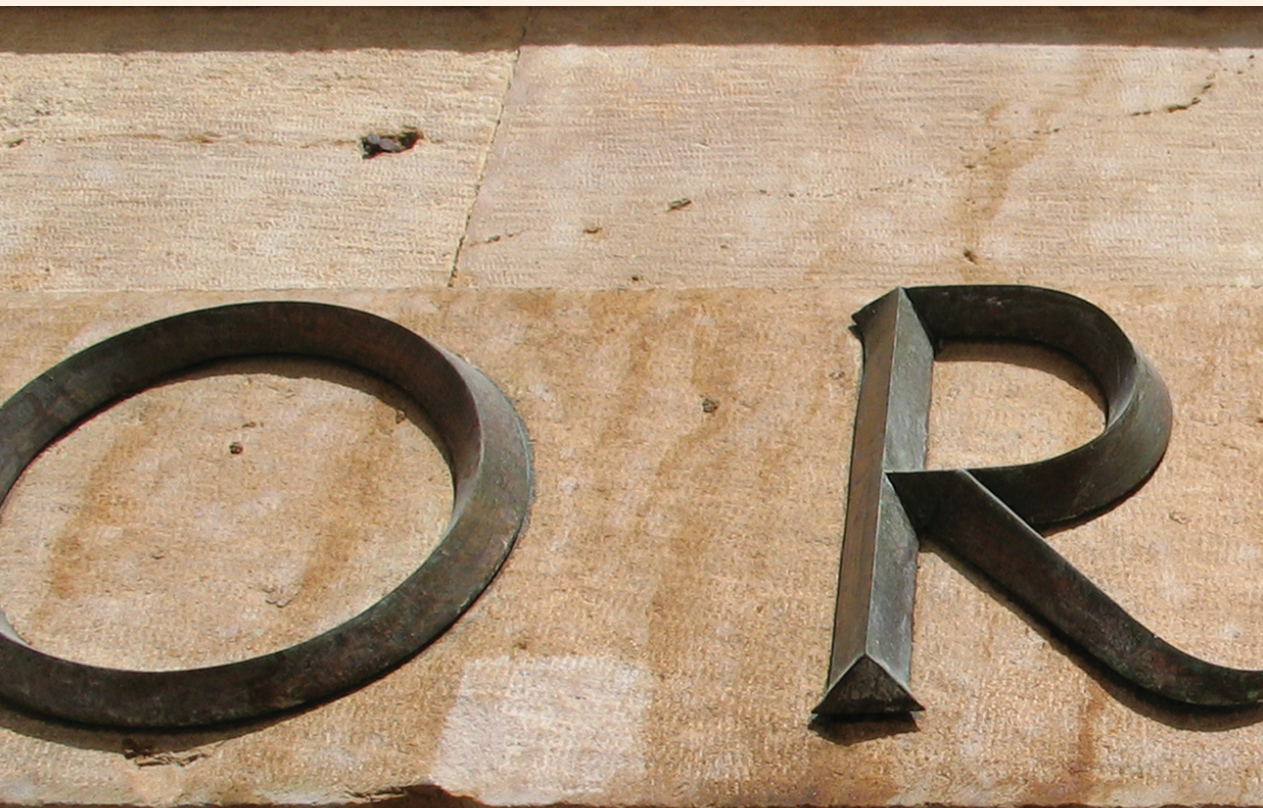
Bottom photograph: Same detail, after laser cleaning

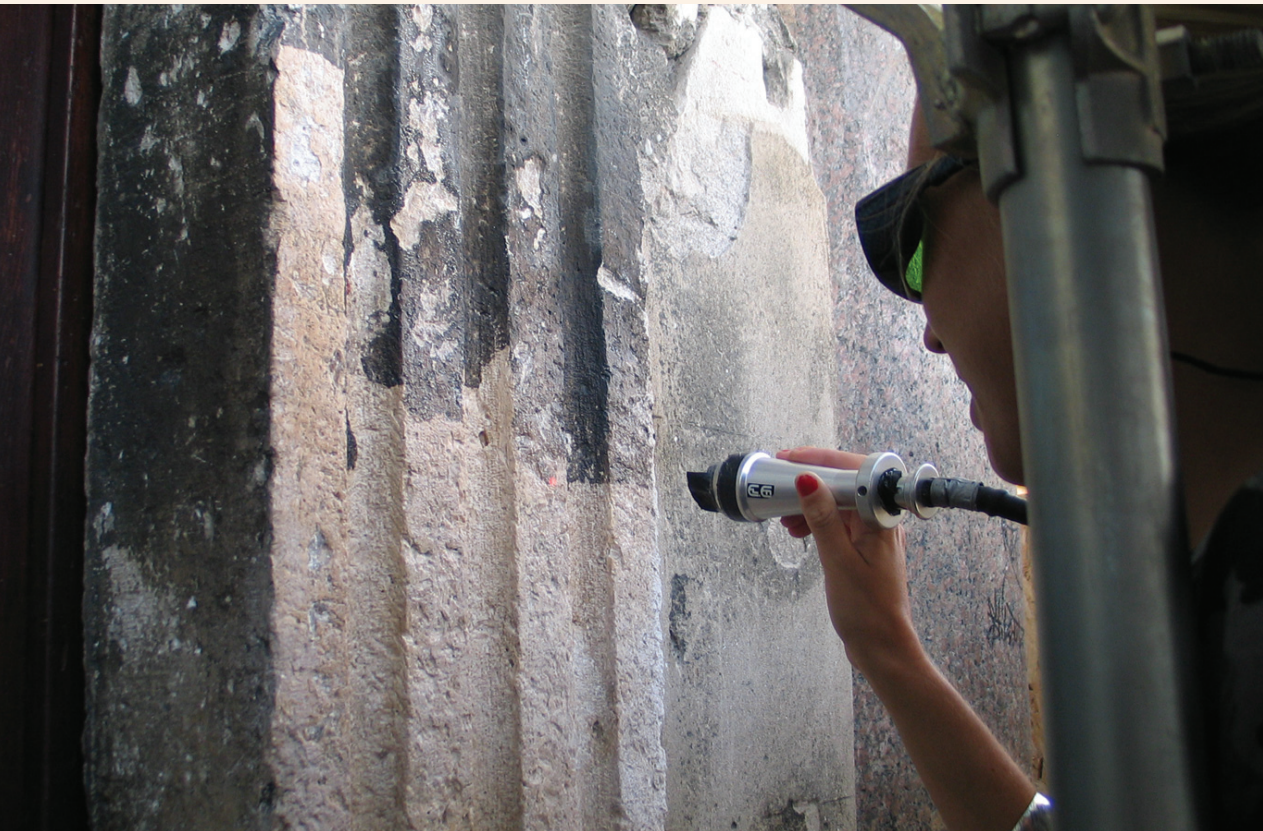
The objective of a conservation-restoration operation is to eliminate the cause of the deterioration and repair the damage. As pointed out earlier, the methodology was adopted during the first phase of the operations: organic and inorganic soiling is removed from the surface of the stone; deleterious salts are drawn out of the structure of the stone; iron elements anchored in the stone are extracted and where necessary replaced with new elements of stainless metal; the cement in the bonds between the stone blocks is replaced with acrylic-lime mortar; cement patches are removed; structural damage is reconstructed with suitable materials; unstable parts of the stone surfaces are consolidated; the upper surfaces of prominent parts are plastered so as to provide an appropriate pitch for drainage of rain water; at the very end, suitable surface-protection preparations are applied to the stone.

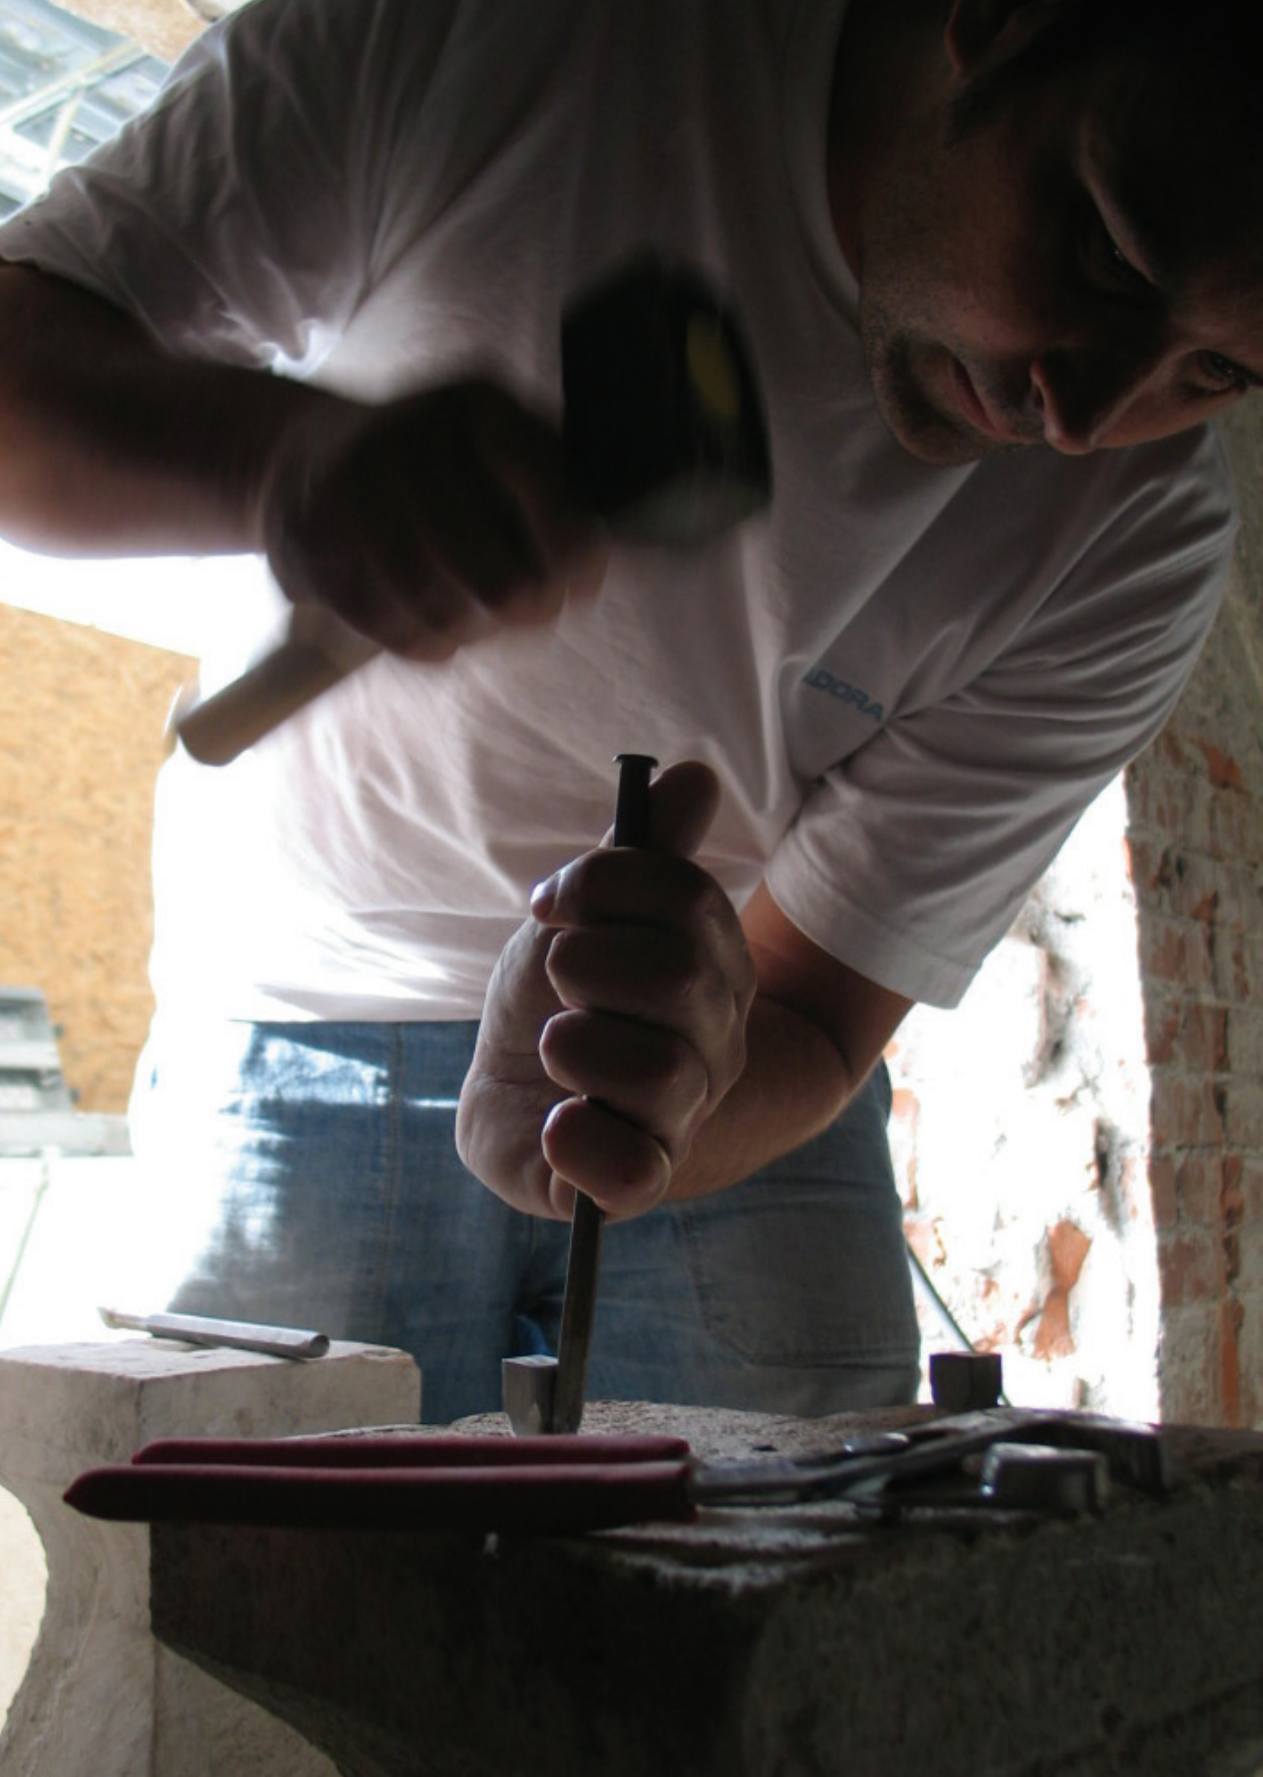
Photograph: Preparation work for the assembly of the balusters

After the making of an architectural drawing of the façade, the documentation of the as-found condition of the building as a whole and in detail was addressed, with written reports, photographs and graphic depictions. The actual works were started on the third floor of the palace with the removal of the organic and inorganic soiling and the cement mortar bonds between the stone blocks. The iron grilles were removed, and the corroded exterior mountings of the shutters were taken out. The broken parts of the stone frames were cemented on, and the damage was stopped up with stone patches. The application of cement on the upper side of protuberant mouldings above the windows was removed and replaced with a layer of artificial stone. Jointing was done with acrylic-lime mortar. The old shutter mountings were taken out and new chrome steel mounting elements were put in instead, and then sealed with molten lead.

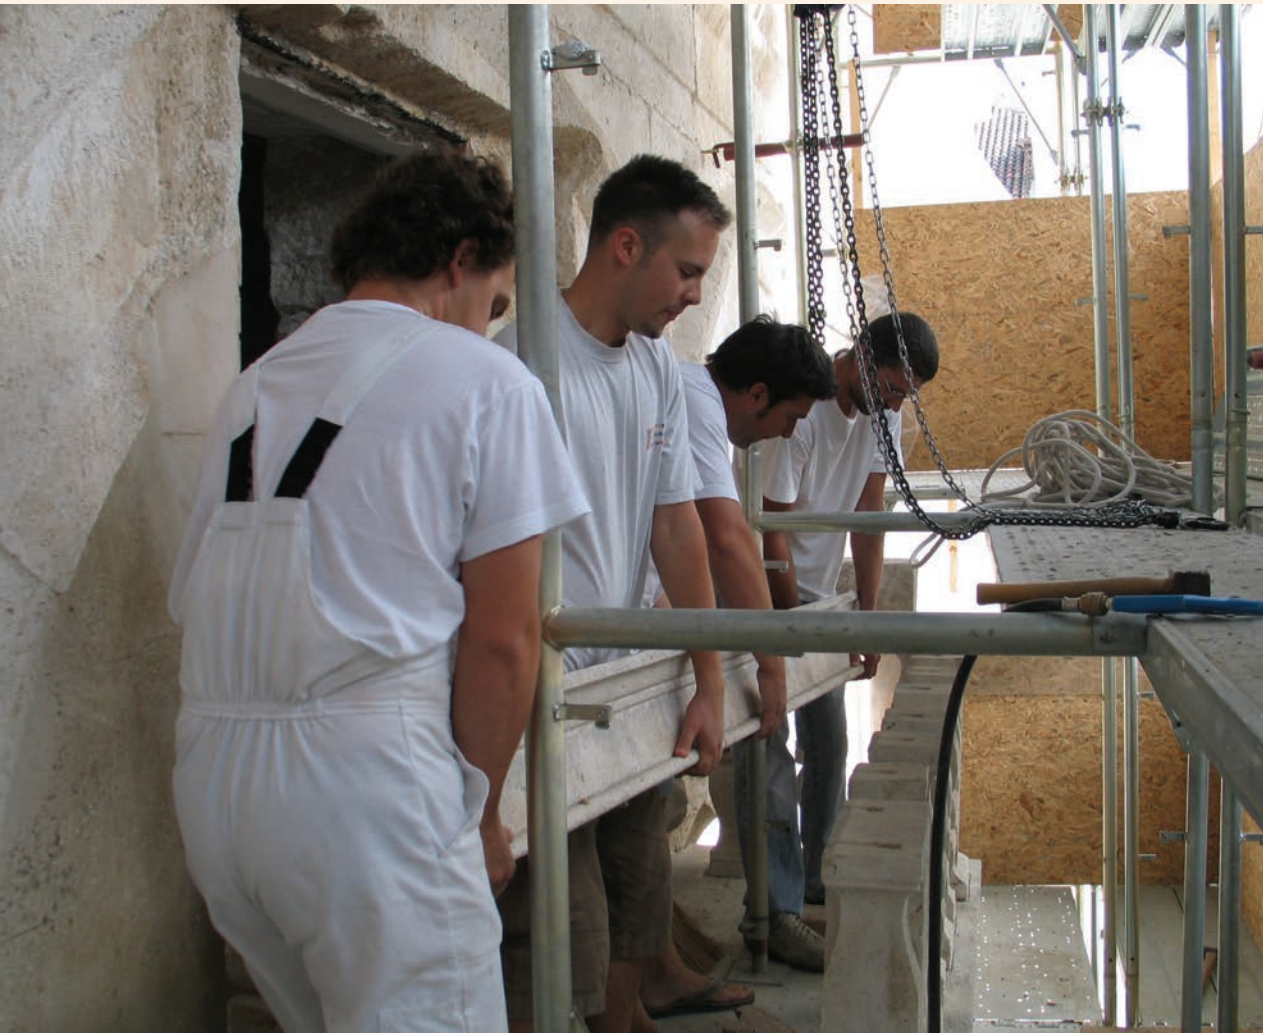
Photograph: Assembly of the stone balustrade of the balcony

One of the most demanding operations was the disassembly and reassembly of the railing of the balcony on the second floor. The missing pillar of the railing was carved in new stone. Structural damage was repaired with artificial stone. Worth mentioning are the reconstruction operations on the Renaissance

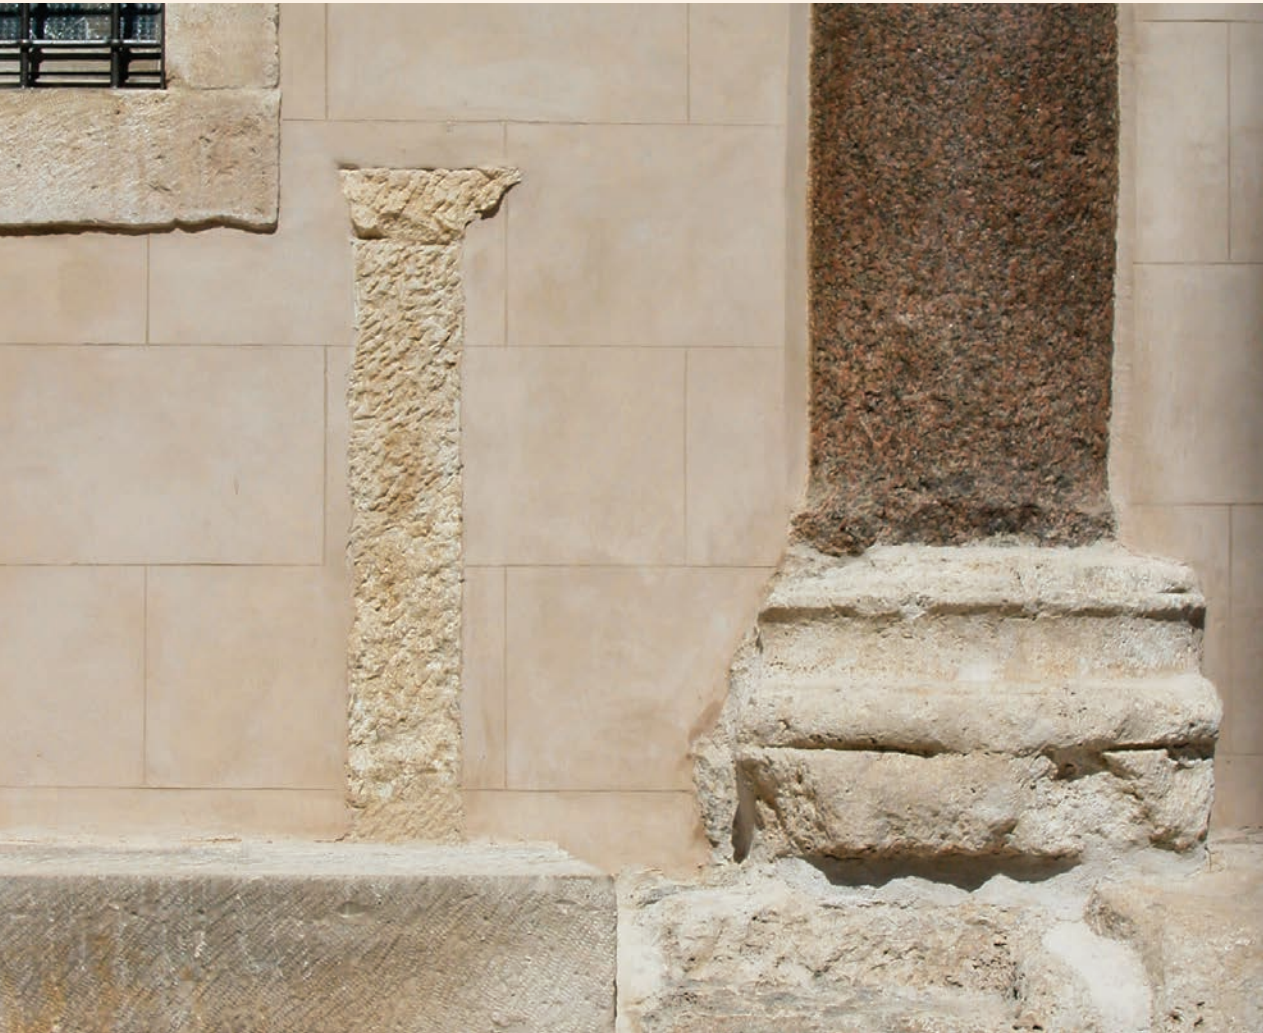
Photograph: Presentation of remains of stone rail found in the ground floor of the palace

headed by Tonči Borovac MSc. Several different kinds of plaster were found on the façade, and it was decided that only lime and lime-cement plaster would be presented. The cement patches were stripped off and parts where the plaster threatened to come off were consolidated. After removal of the inorganic dirt and more recent coats, desalination was carried out on problem areas. The last step was reconstruction of the missing parts of the stucco. In the case of reconstruction operations to the plaster on the ground floor, particular attention was paid to presentation of the remains of a stone railing of 1860 found that had been placed there in 1860 on the place of a predecessor.

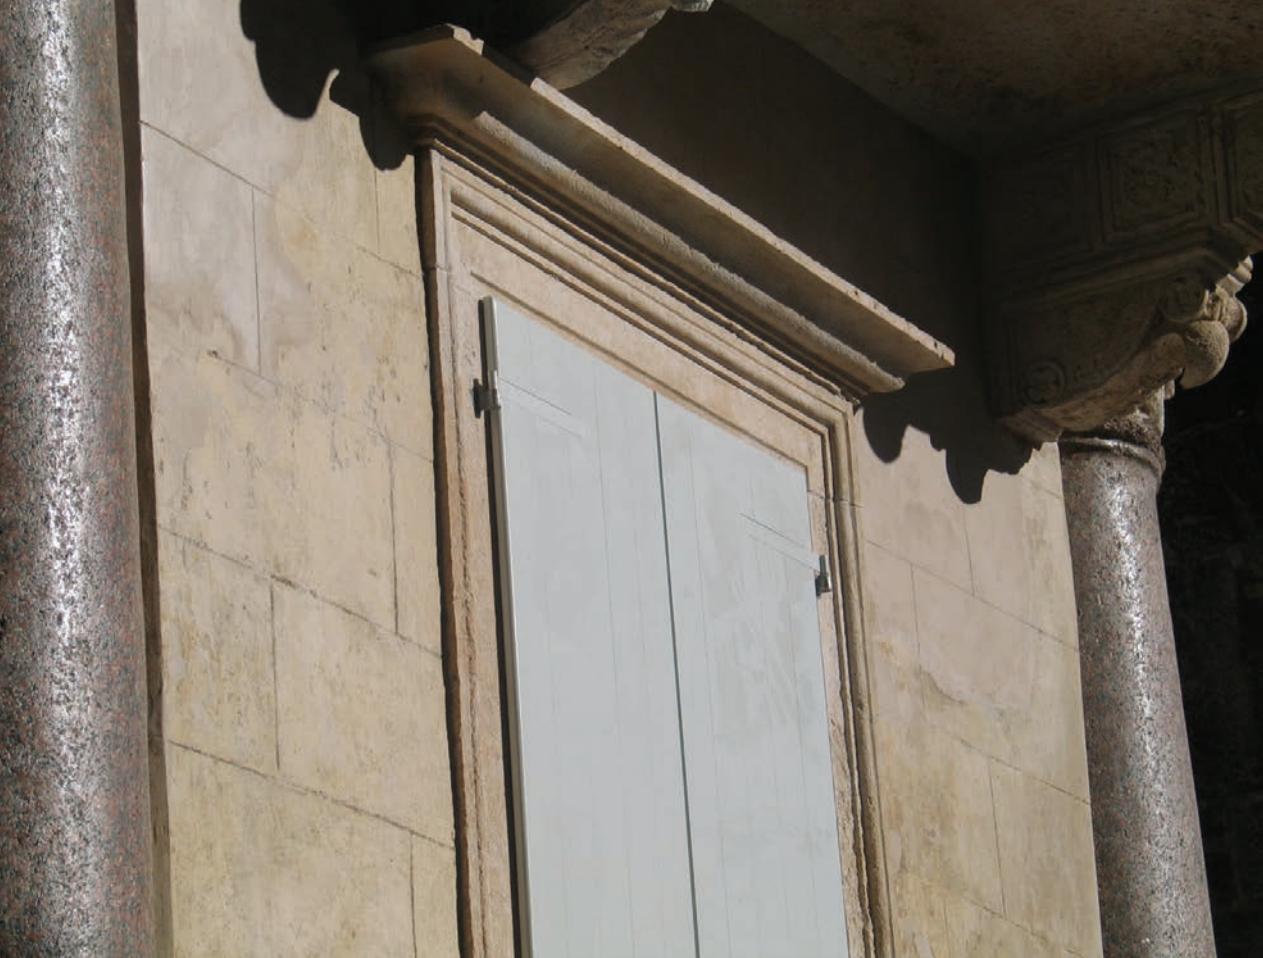
Top photograph: Detail of the façade after the conservation-restoration operation
